RESOLUTION ADOPTING A NEW STORM WATER MASTER PLAN AND ASSOCIATED CAPITAL IMPROVEMENT PLAN FOR THE CITY OF LIBERTY AS DEVELOPED BY HDR ENGINEERING INC.

City of Liberty - Stormwater Master Plan
Technical Memorandum

City of Liberty, Missouri – Stormwater Master Plan Condition Assessment Summary Report

Stream Assessment Findings Summary

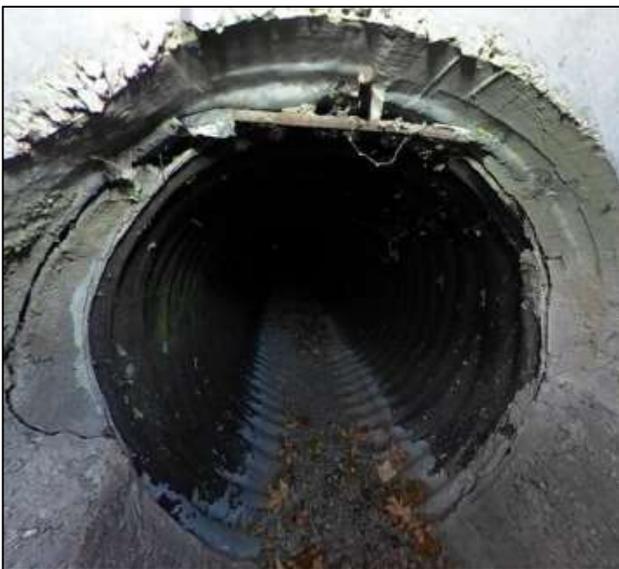
C11-10-1337: Rebar intruding through pipe seal

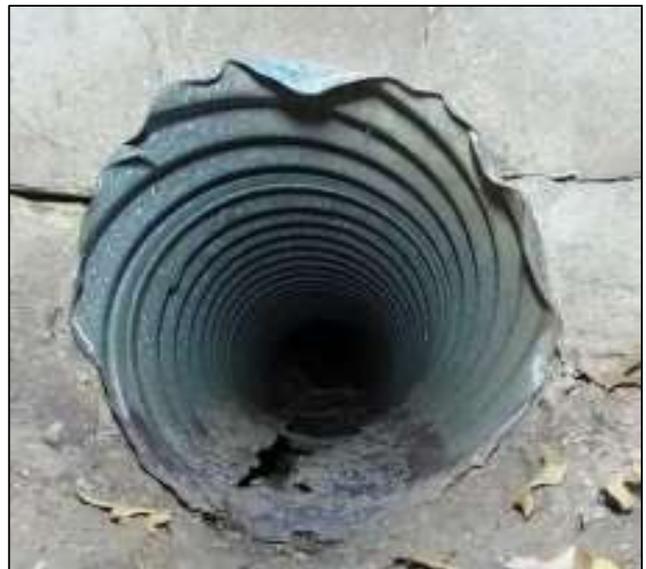
A23-24-890: Pipe rusted through at the bottom

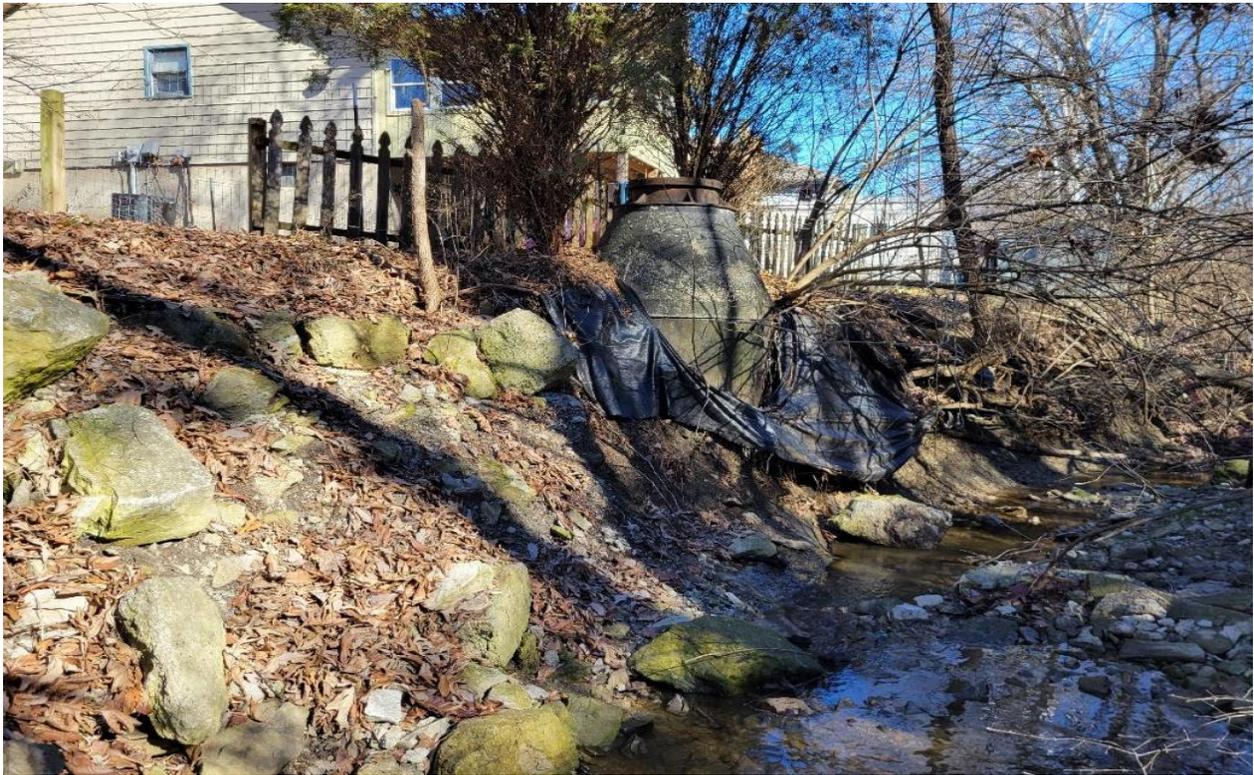
Figure 2-2. Observed Stream 1 Bank Erosion (Location ID: S1.17)

Figure 2-2 illustrates the bank erosion posing a threat to nearby residences and exposing a manhole. Multiple instances of infrastructure risk were identified during investigations of Stream 1. Table 2-3 displays the inventory of instability concerns identified with severity rating of 3 or higher along Stream 1.

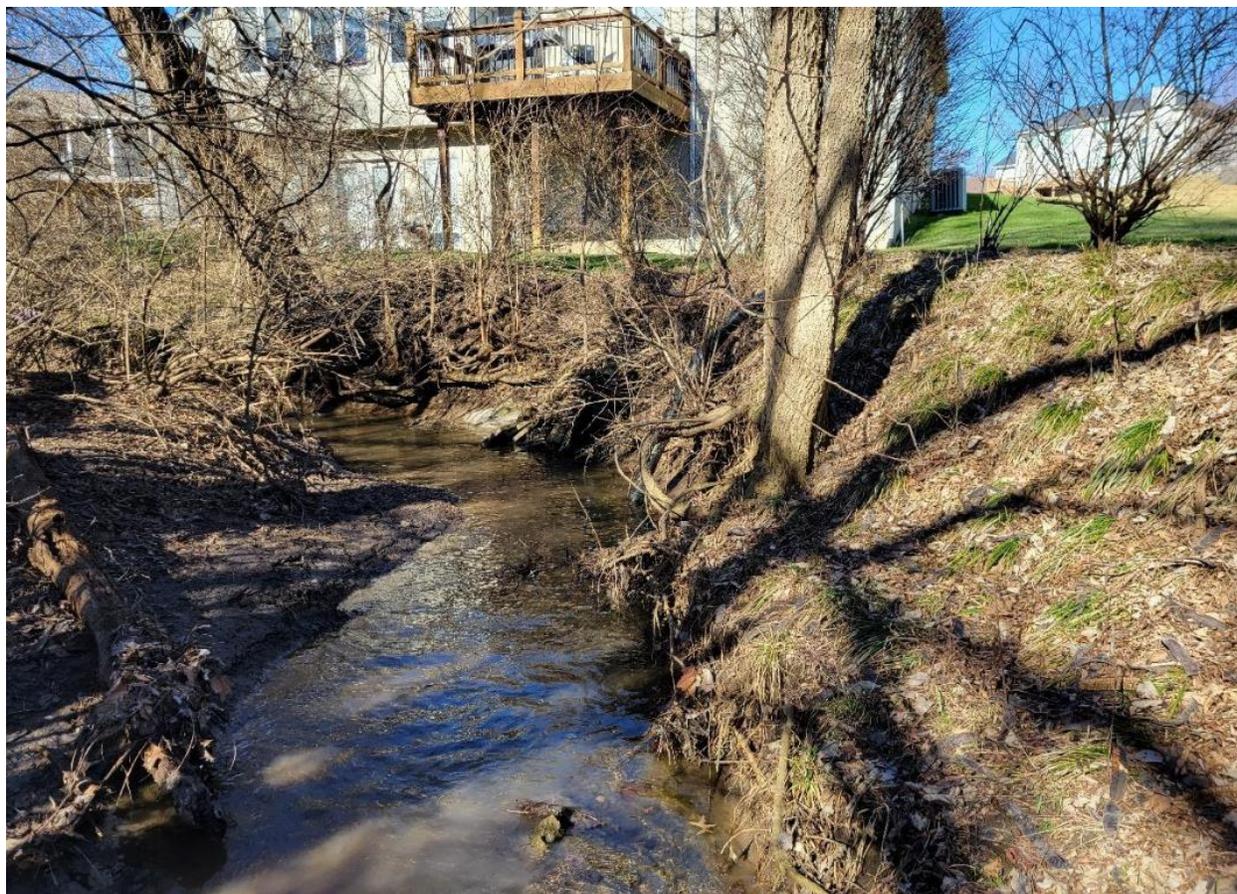
Figure 2-3. Observed Bank Erosion Occurring in Stream 2 (Location ID: S2.30)

The erosion of the stream banks poses risks to nearby residential buildings and public infrastructure, as evidenced in the Figure 2-3, which depicts the presence of slump-off slope without vegetation and meander downcutting along the bank.

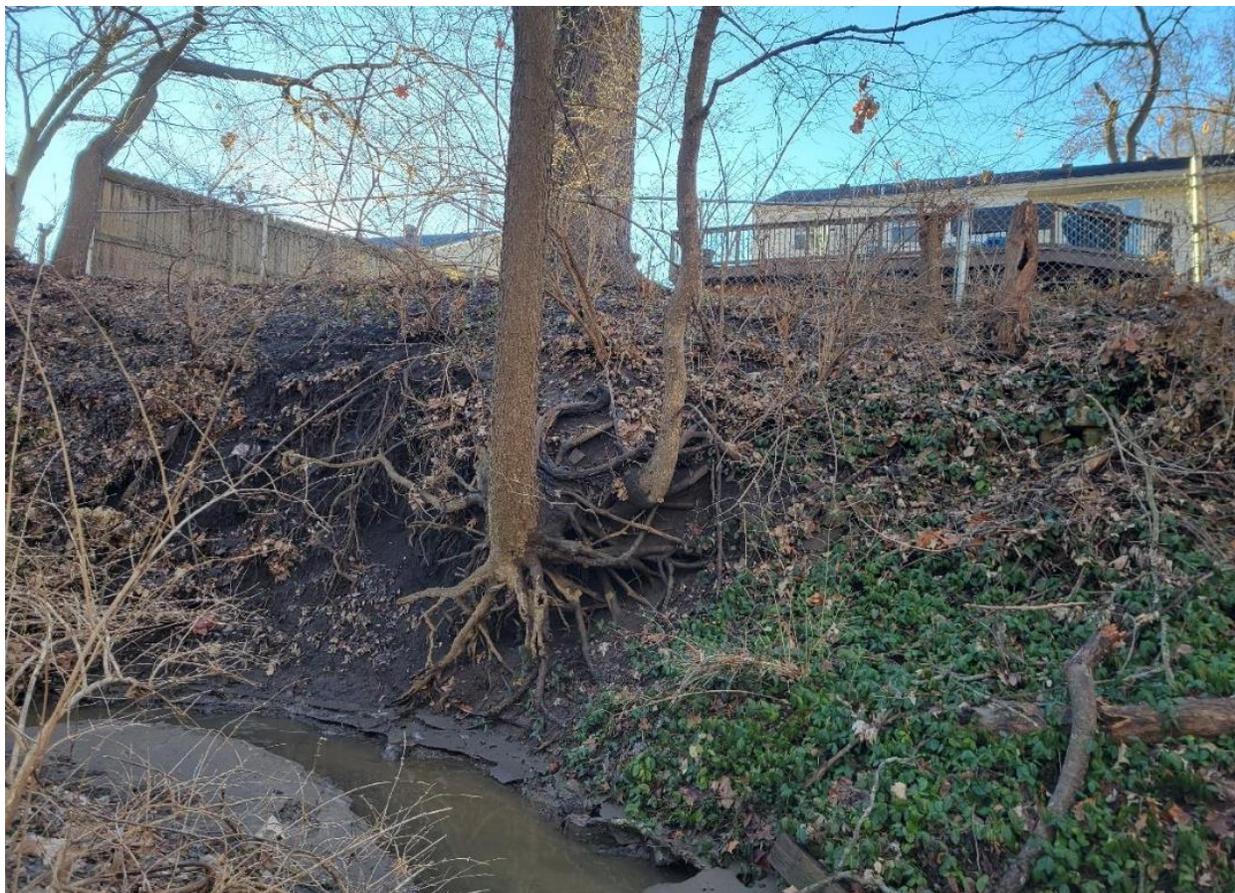
Figure 2-4. Observed Stream Bank Erosion along Stream 3 (Location ID: S3.24)

Figure 2.4 illustrates stream bank erosion along Stream 3, revealing exposed tree roots and fluvial erosion increasingly close to residential areas, marked by the fence line. The erosion poses a significant risk to property boundaries.

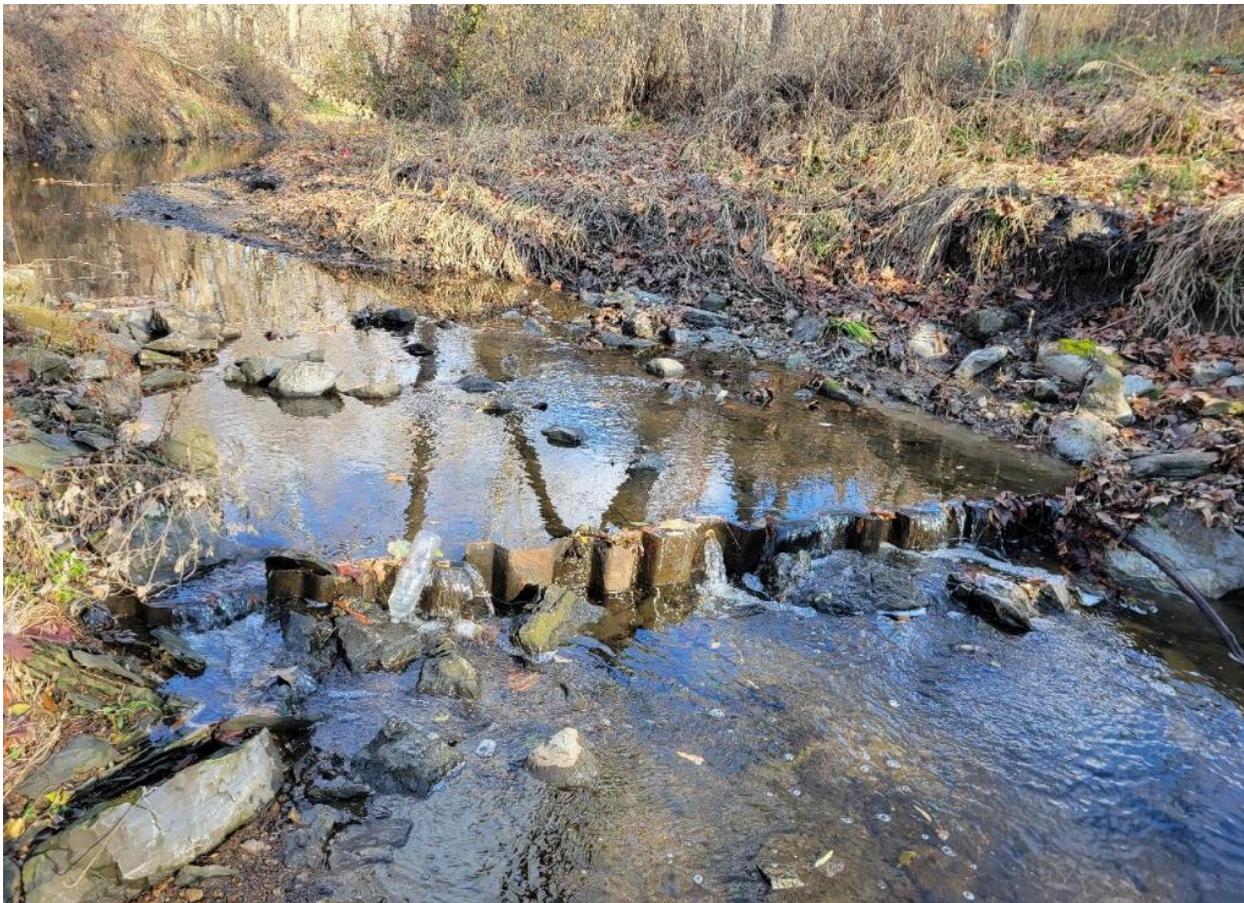
Figure 2-5. Knickpoint Observed within Stream 4 (Location ID: S4.35)

A knickpoint is shown in Figure 2-5. A knickpoint is a location within a stream with a sharp change in the stream bed slope, most often a steep drop. A knickpoint can be an indicator of stream degradation because it often represents a sudden interruption in the stream's natural equilibrium as it actively adjusts to new conditions. As the stream flows over the knickpoint, it accelerates the erosion process downstream, leading to channel incision, widening, and increased sediment transportation. This was a typical knickpoint observed during the stream investigation.

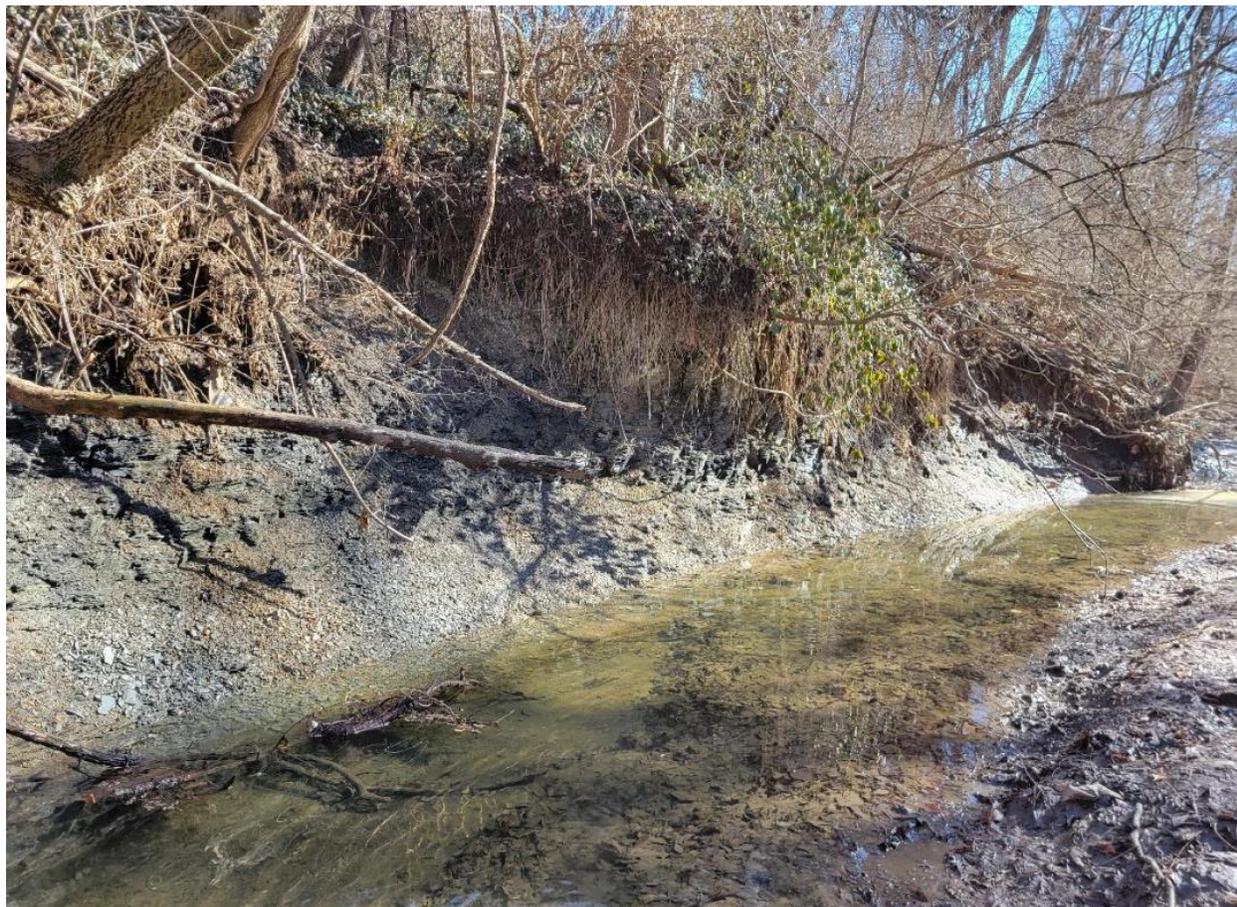
Figure 2-6. Bank Erosion Observed in Stream 5 (Location ID: S5.34)

In Figure 2-6, bank fluvial erosion on Stream 5 is depicted, with exposed orange hairy roots indicating recent exposure, likely within the last six months. Additionally, the image portrays surfing trees, which are trees leaning or falling into the stream as a result of erosion undermining the bank beneath them.

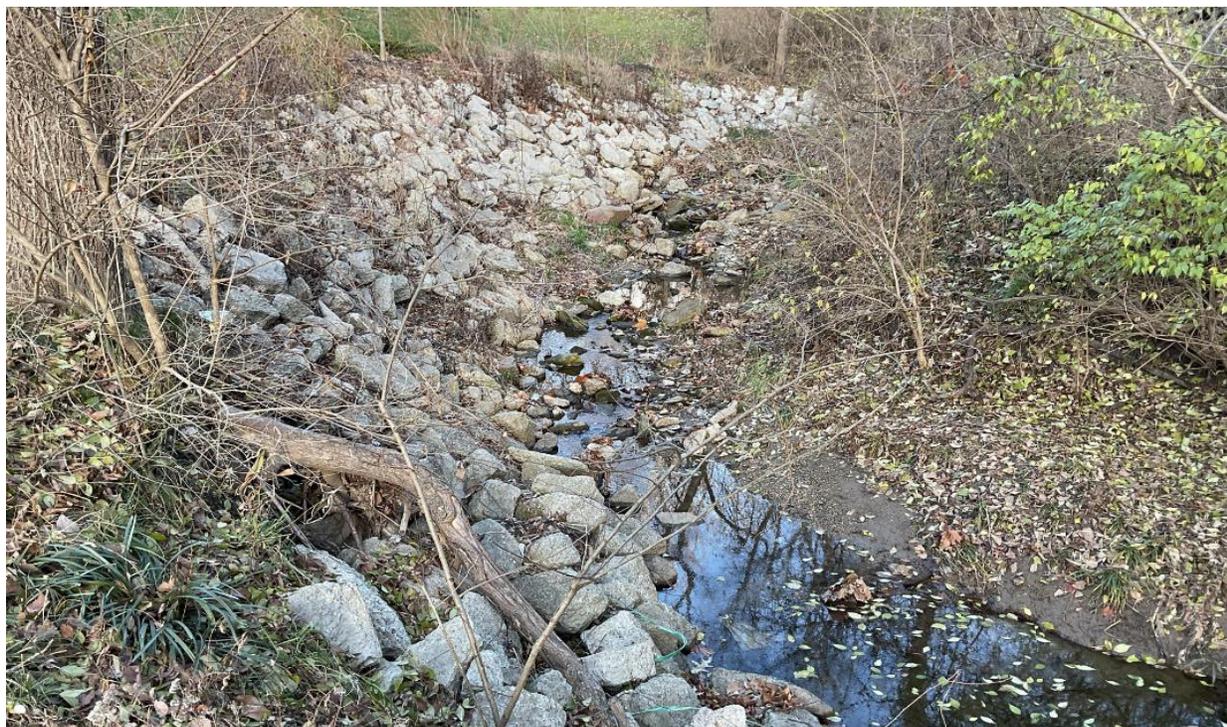
Figure 2-7. Rock Riprap along Bank on Stream 6 (Location ID: S6.23)

It was observed that rock riprap was added along multiple bank locations within the streams investigated. Figure 2-7 shows riprap encountered within Stream 6 with the purpose of bank erosion control.

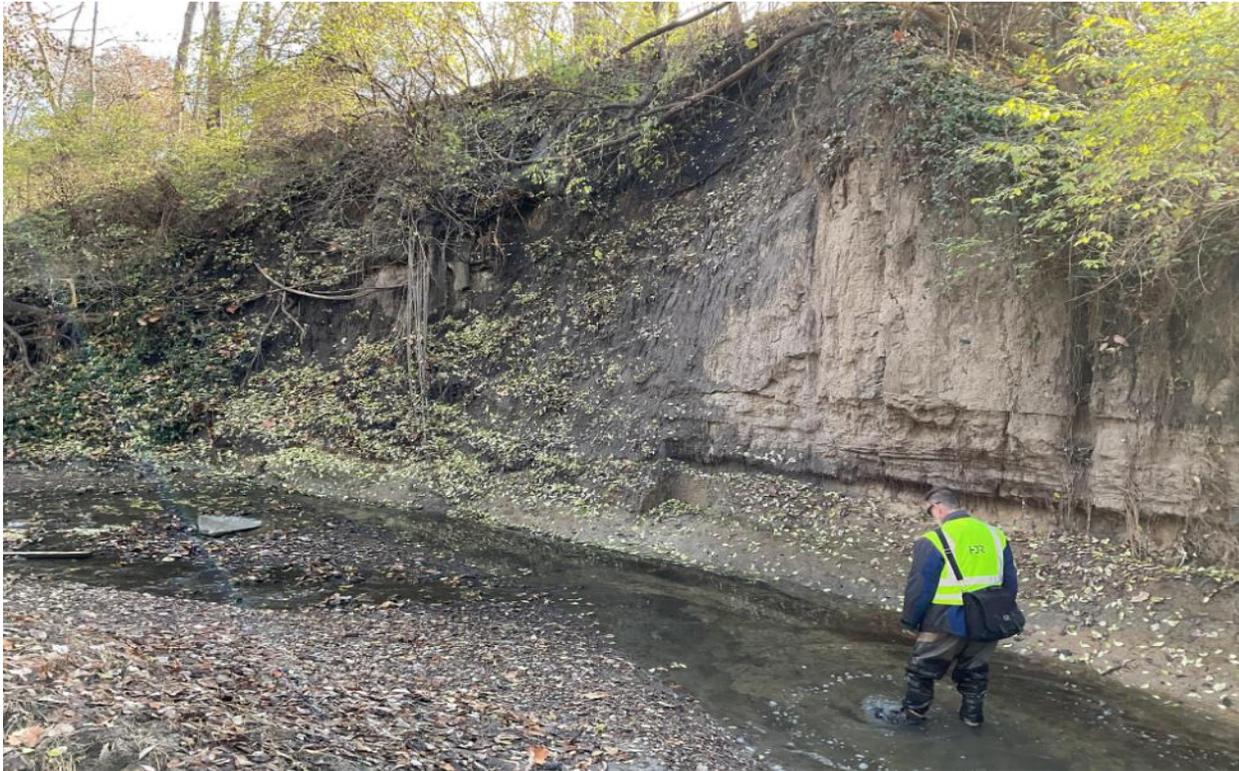
Figure 2-8. Bank Failure Observed on Stream 7 (Location ID: S7.66)

A bank failure estimated over 30 feet in height was observed along Stream 7. This specific location does not involve public infrastructure and thus is not listed within Table 2-9, however, is available within the Master Plan hub – Stream Bank Investigation tab.

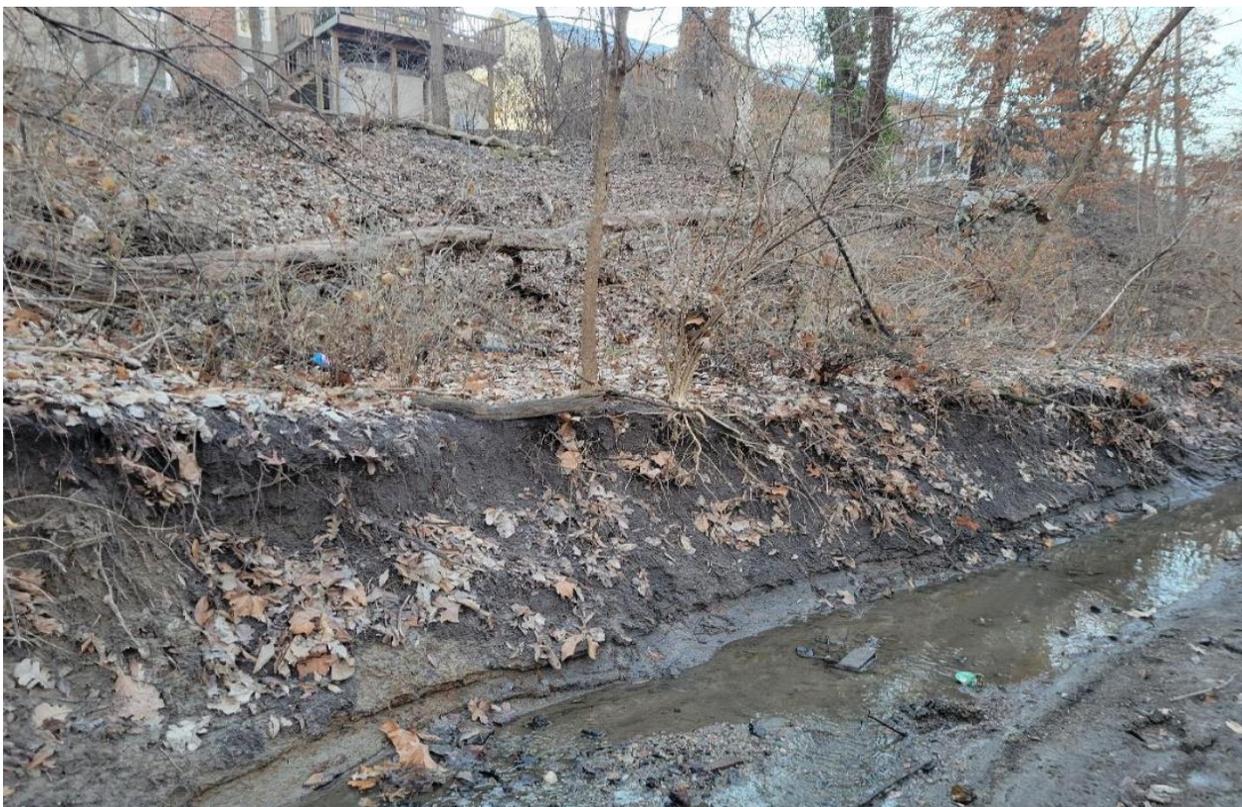
Figure 2-9. Stream Bank Erosion observed in Stream 8 (Location ID: S8.12)

Figure 2-9 illustrates the presence of abandoned terraces, fluvial bank erosion, exposed tree roots, and at-risk backyards along Stream 8 that are indicators of stream degradation.

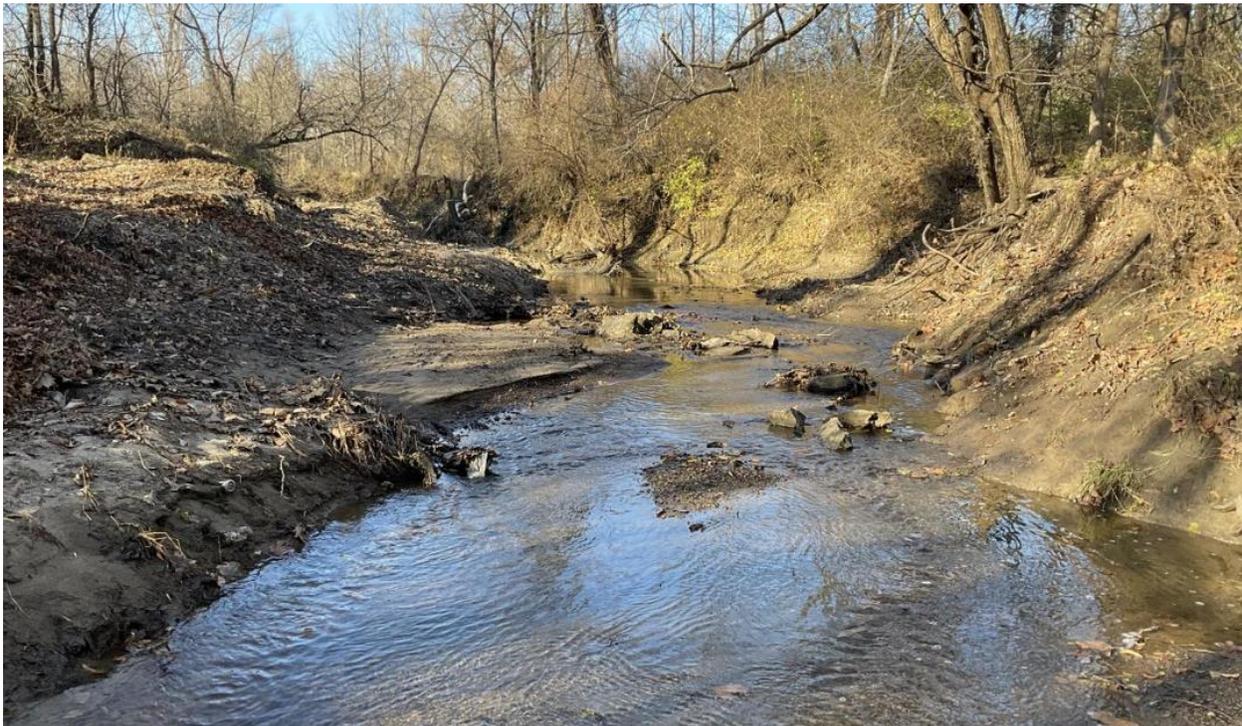
Figure 2-10. Stream bank erosion along Stream 9 (Location ID: S9.5)

Figure 2-10 shows an abandoned terrace and mini knickpoint observed on Stream 9.

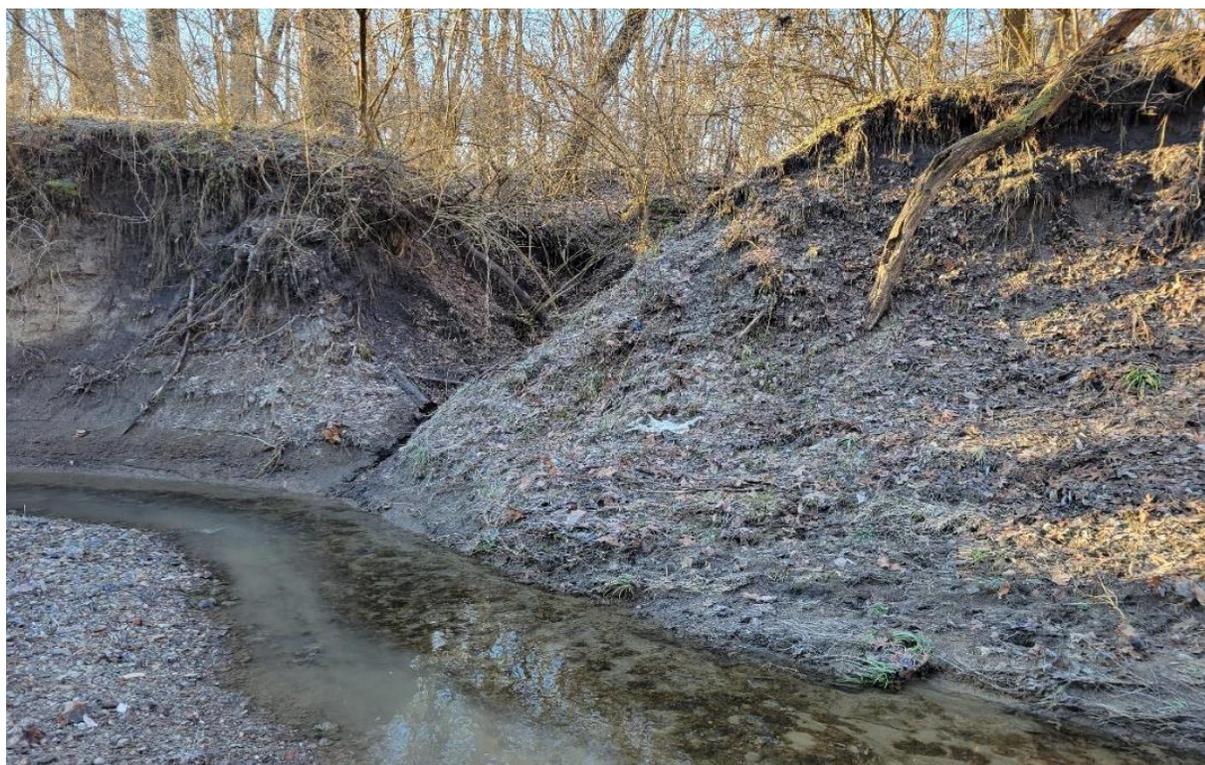
Figure 2-11. Stream Bank Erosion Observed along Stream 10 (Location ID: S10.3)

Figure 2-11 shows erosion occurring on a steep bank within Stream 10.
