City of Liberty, MO  
Attn: Tom Garland CPRP  
1600 S Withers Road  
Liberty, MO 64068

Echo GPR Services performed a Ground Penetrating Radar (GPR) scan to identify anomalies that could be consistent with potential unmarked graves at the New Hope/Fairview Cemetery. The eastern portion of the cemetery was scanned in 3 separate sections for ease in collecting and processing the data. Based on the GPR data collected on site several anomalies were observed in the data over both marked and unmarked grave areas. These anomalies are consistent with possible graves or other disturbances not consistent with the surrounding soils

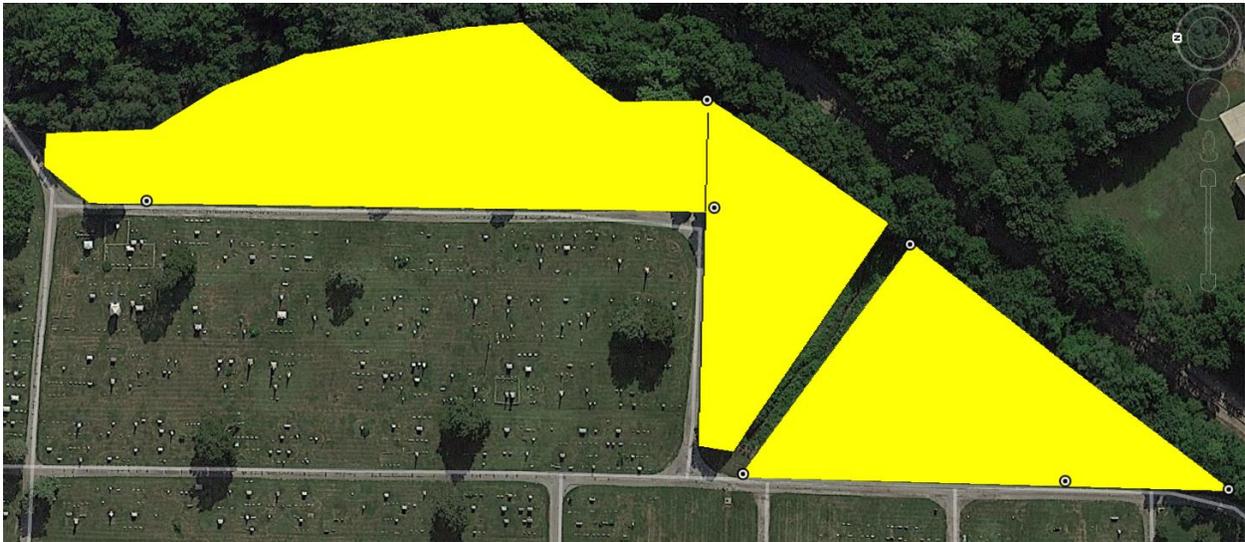
**Figure 1**

Figure 1 below shows the 3 separate areas scanned. Figure 1 is rotated 90 degrees so north is pointing to the left. This is to aid in display in the report. The 3 areas will be referred to as the North, Middle and South (New Hope) sections. Each section was scanned in north and south passes at 2ft intervals. These individual files were then used to re-create each section with the GPR data and create slices of GPR data of below the surface anomalies.

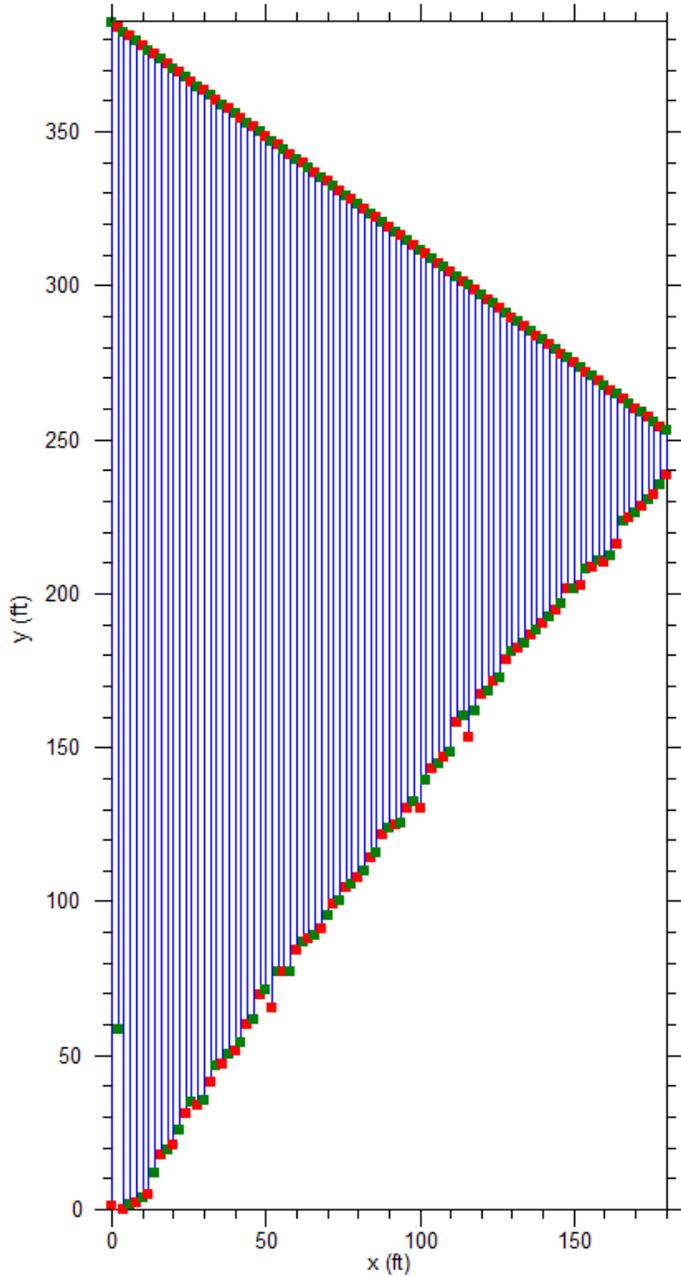
Figure 2

The 3 grid paths are shown below in Figures 2-4. These path maps are re-orientated with north in the standard orientation. The South section grid path map is shown below in Figure 2. 94 individual scans totaling 3.4 miles of data was collected for this section.

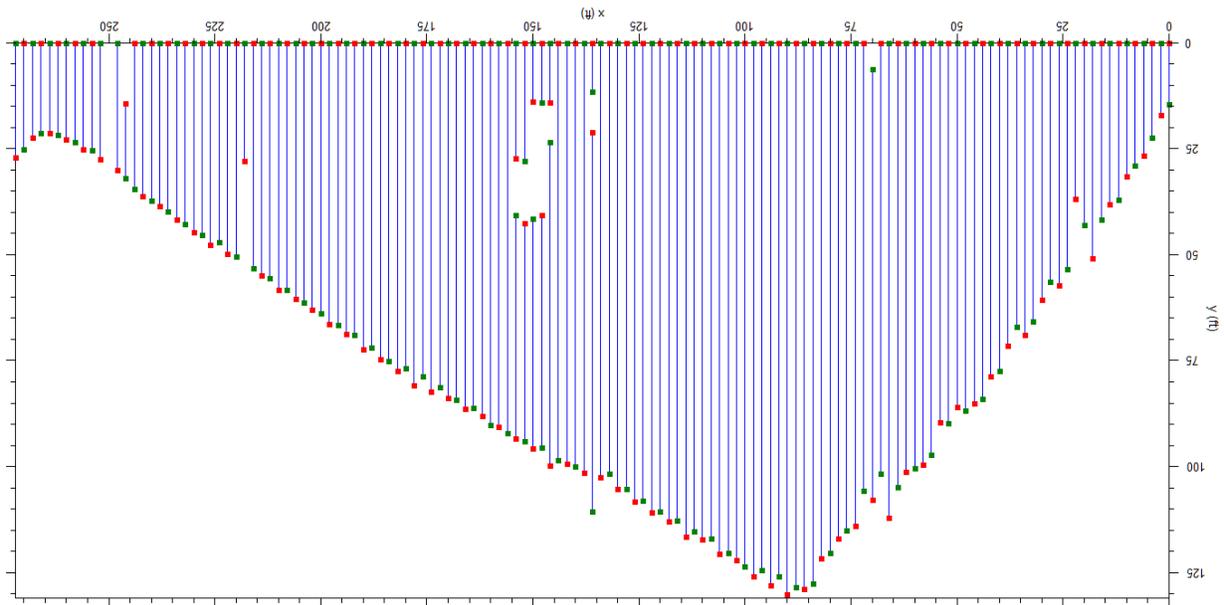
**Figure 3**

The Middle section grid path map is shown below in Figure 3. 143 individual scans totaling 1.9 miles of data was collected for this section. Intermittent gaps in the profile are spaces working around obstacles such as trees or headstones with a large flower area around them.

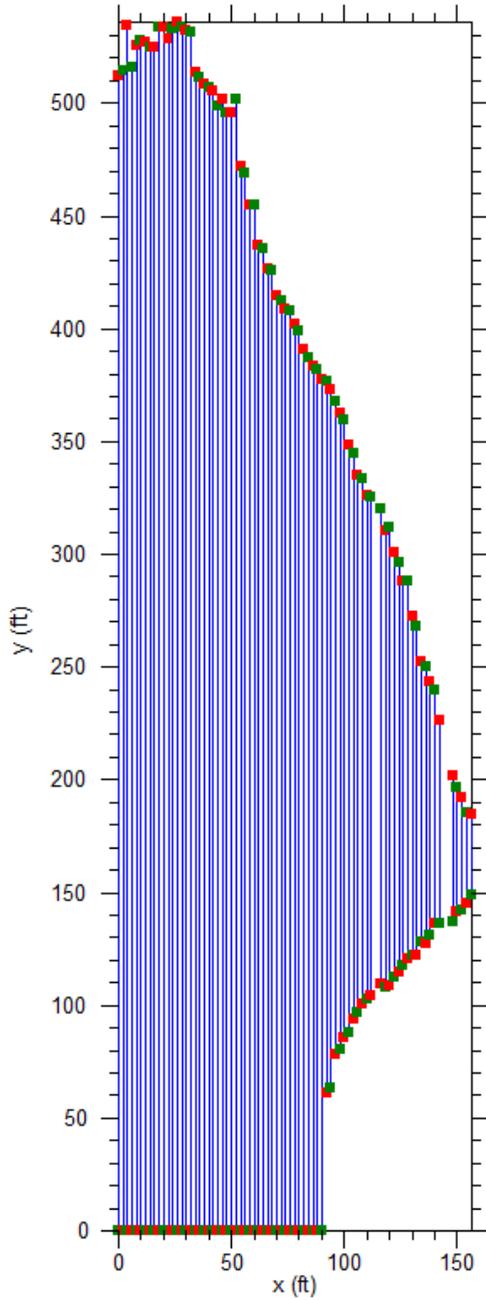
Figure 4

The North section grid path map is shown below in Figure 4. 78 individual scans totaling 5.2 miles of data was collected for this section.

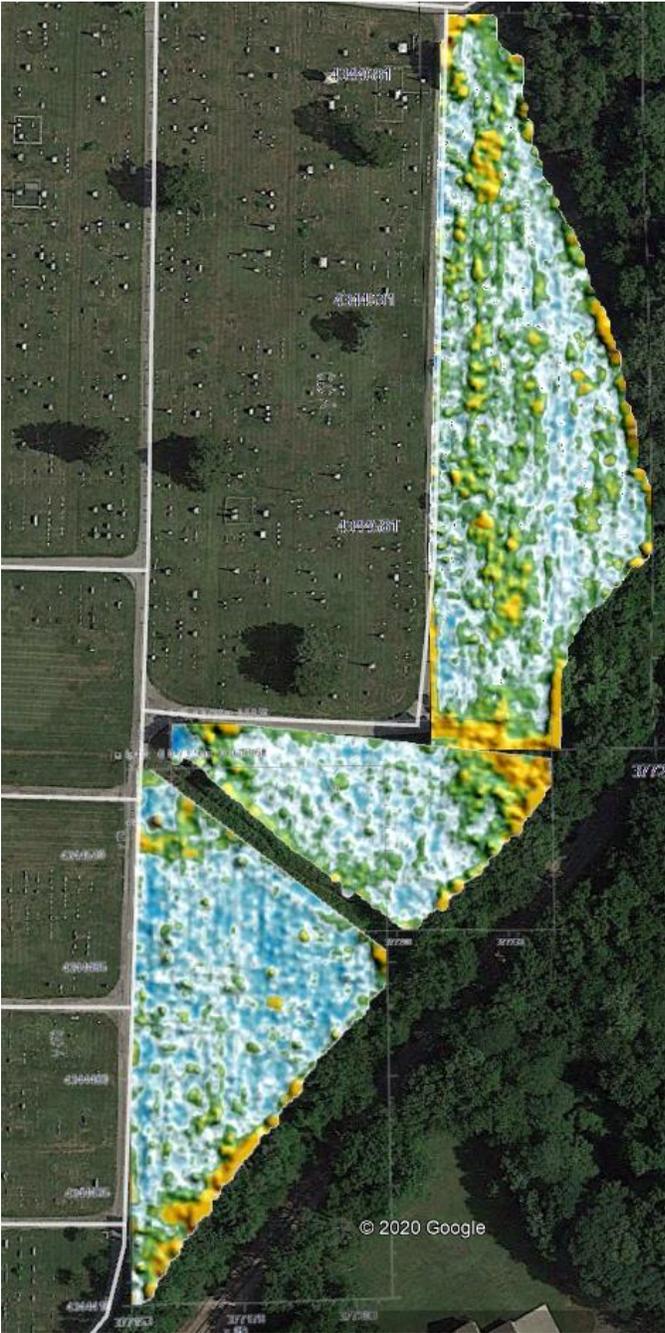
Figure 6 shows an aggregate overlay of all 3 sections scanned of all strong reflectors from the near surface to the depth of the GPR systems data. Notable high reflections are very observant along the edges of the tree lines, indicative of reflections likely caused by vegetation root systems.

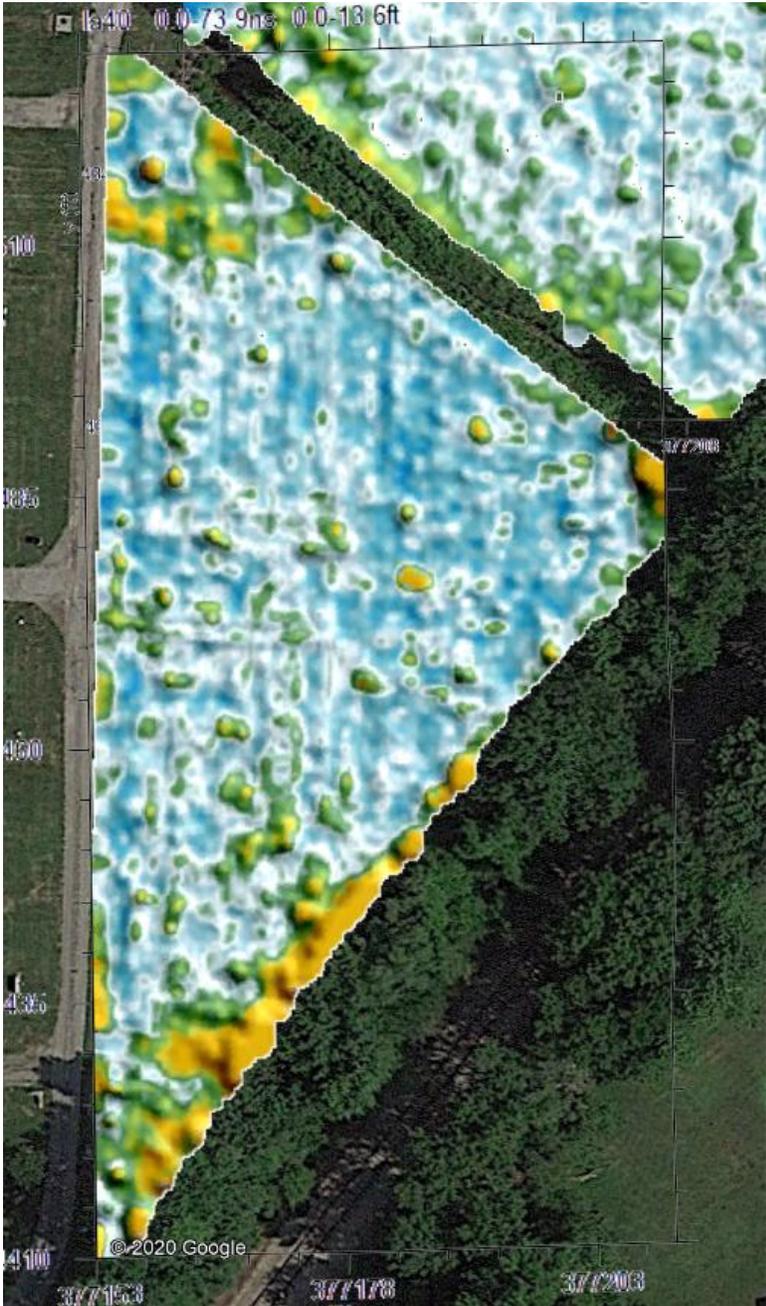
Figure 7

In the South (New Hope) section (Figure 7) of the data there is strong reflections in the very northwestern tip of the data near the drainage culvert. Based on a 1963 aerial (from [historicalaerials.com](http://historicalaerials.com)) there appears to be a building or other structure that was at one time located in this area. The high reflections may indicate a possible foundation or debris left from the construction or removal of this structure. The 1963 aerial is shown in Figure 9.

Based on the GPR data it does not appear that there are any significant anomalies consistent with graves in this South (New Hope section) that do not already correspond with headstones at the site. This does not rule out the possibility that unmarked graves could be in the area, just that the GPR data does not clearly indicate any possible anomalies.

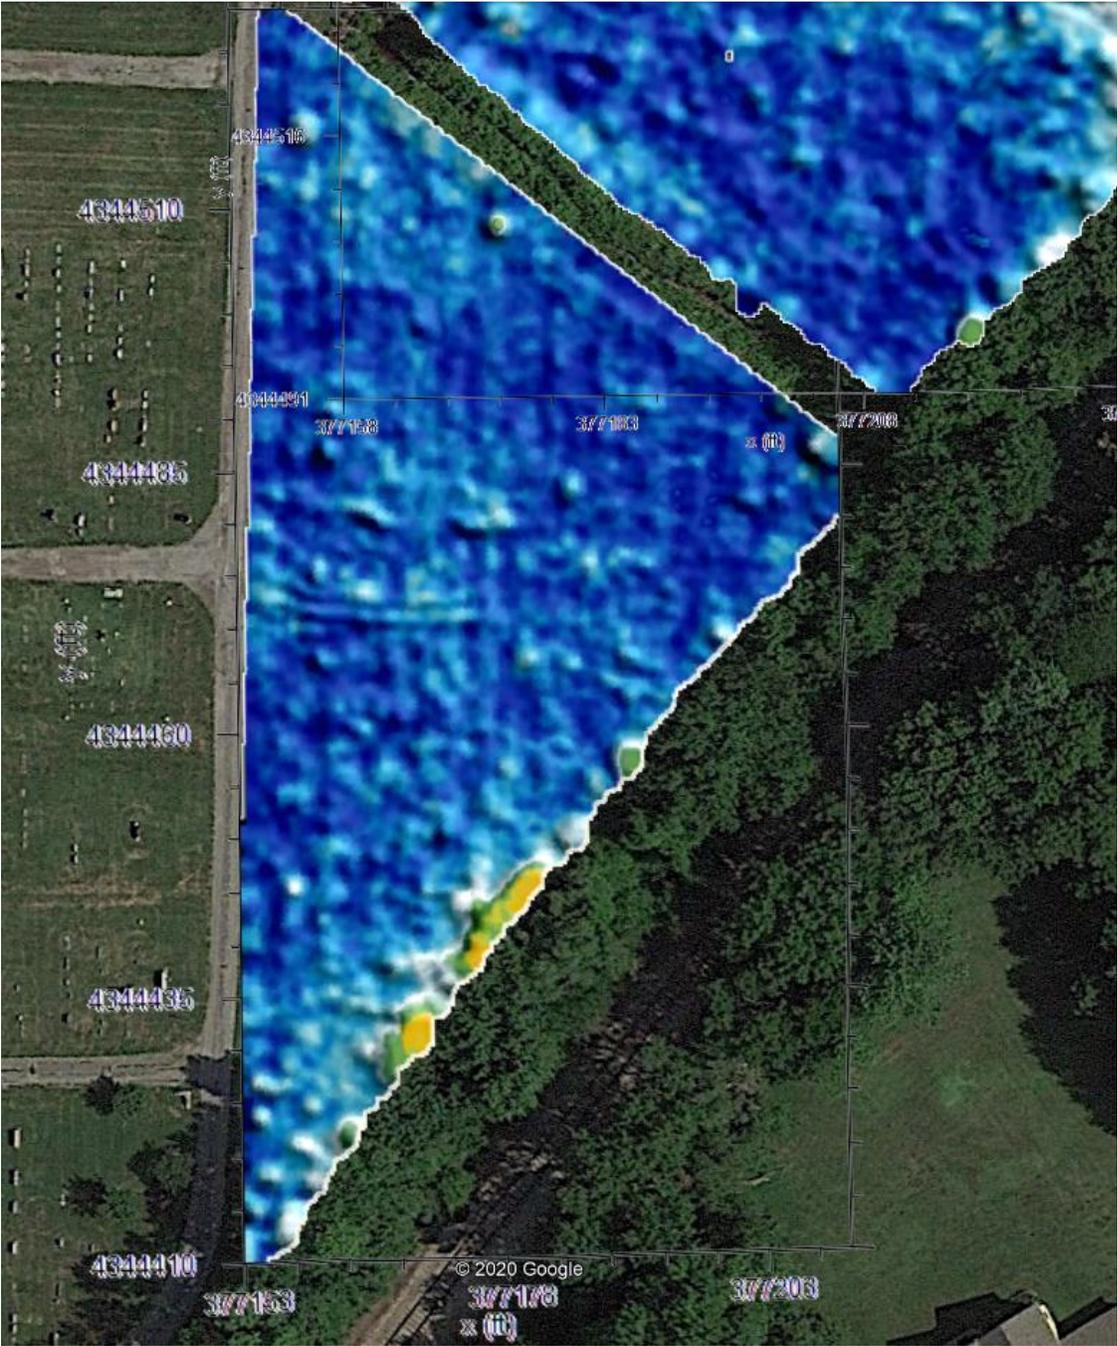
Figure 8

Another relatively new technique in analyzing older historical cemeteries is to analyze the data showing the aggregate overlay of only the weakest reflectors. This technique is used to help determine areas of possible backfill and show disturbances that may not be present in overlays of strong reflectors. This overlay is shown in Figure 8.

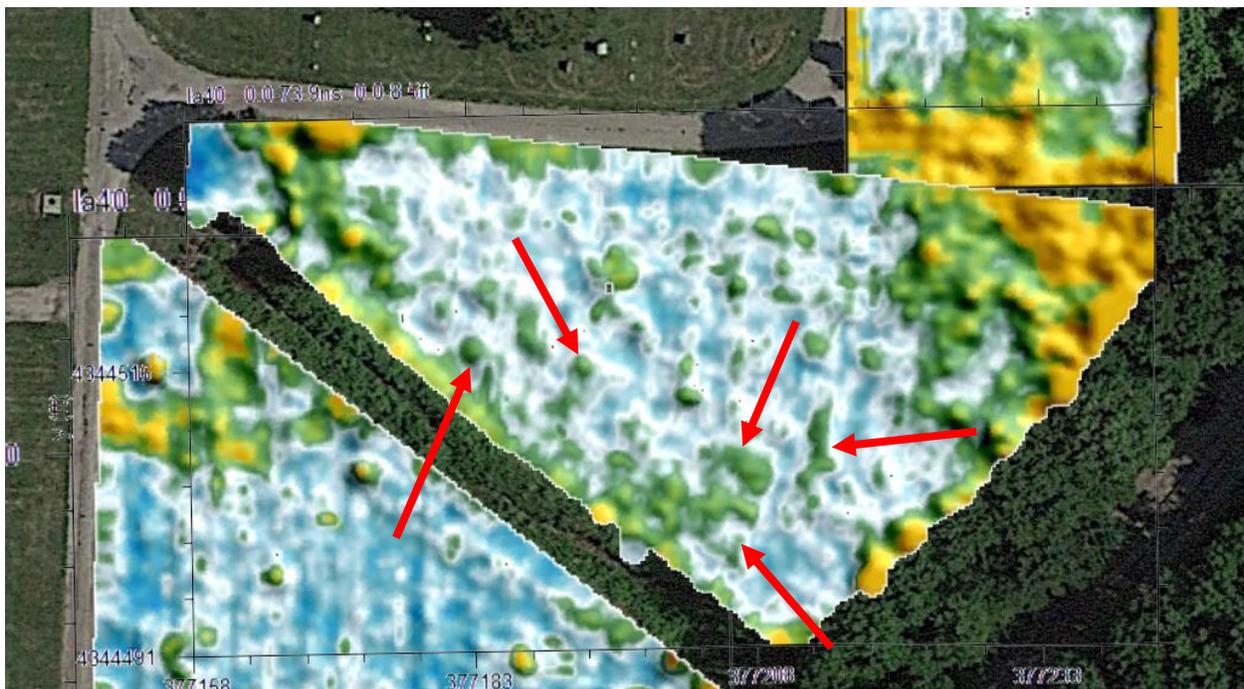
Figure 10

The middle section (Fairview Cemetery) for aggregate strongest reflectors is shown below in Figure 10. This area shows a significant amount of reflections around the perimeter especially to the east, west and southern edge. The areas to the east and west are interpreted to be the tree root systems underground. Analysis in this area is difficult due to the large structure of roots and no interpretation of unmarked graves in these areas can be provided. There are other anomalies identified with red arrows that show disturbances underground that could be identified as anomalies underground not consistent with the surrounding soils. Each red arrow points to areas in green that could be possible unmarked graves. Those

anomalies in green that do not have a corresponding arrow are relatively close (within GPS error) to known marked out graves or are close enough to the tree roots to be unable to analyze.

Based on the GPR data of this middle section there are some anomalies that are consistent with possible unmarked graves. This does not conclude that these anomalies are graves, just that the anomalies in these areas do not appear to be consistent with surrounding soils.

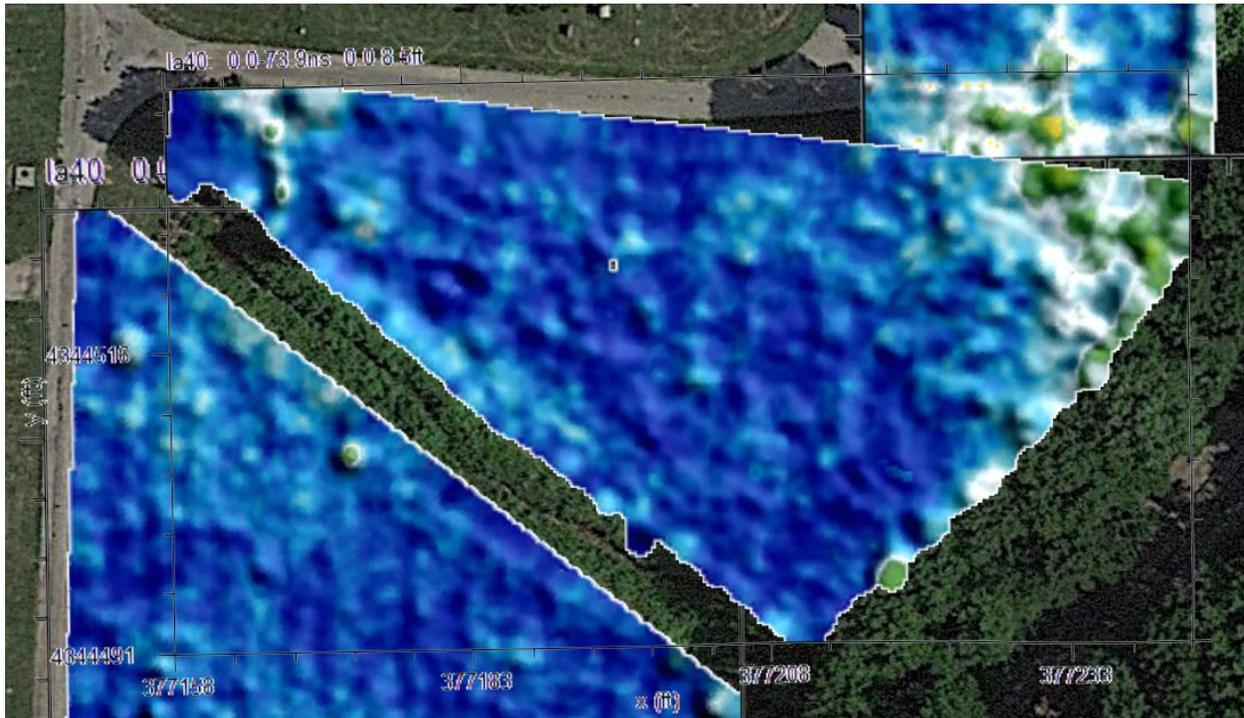
**Figure 11**

Figure 11 shows the aggregate image of relatively weakest reflectors in the same area. In this image there does not appear to be anomalies in this data analysis to add any other areas of interest in this area.

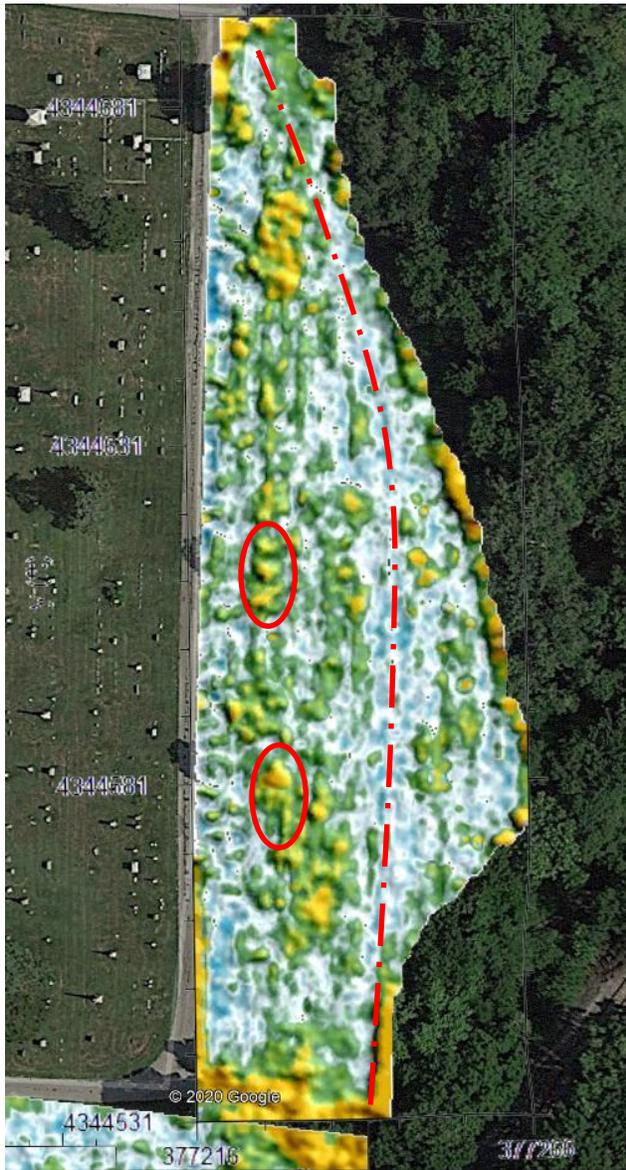
Figure 12

The north section (Fairview Cemetery) for aggregate strongest reflectors is shown below in Figure 12. The same strong reflections on the east and south portions of the image correspond with proximity to vegetation and again are likely reflections from the roots underground. This area shows more anomalies in the data than the other 2 sections scanned. Two areas circled in red are in areas where there were existing trees on the site. The reflections in these areas are likely of the roots from these trees. A red center line is overlaid onto the data where a “path” appears to cut through this cemetery. A historical image from 1960 shows a possible paved path going through this section of the cemetery and the GPR indicates this could be the approximate path of the road as minimal subsurface disturbances are seen along this line. There is a significant amount of disturbances in this section both east and west of the interpreted path. Some of these anomalies appear to be consistent with possible graves as there is a “linear” feature in which these anomalies appear in rows from north to south, consistent with cemetery burials.

Based on the GPR data of this north section there are anomalies that are consistent with possible unmarked graves. This does not conclude that these anomalies are graves, just that the anomalies in these areas do not appear to be consistent with surrounding soils.

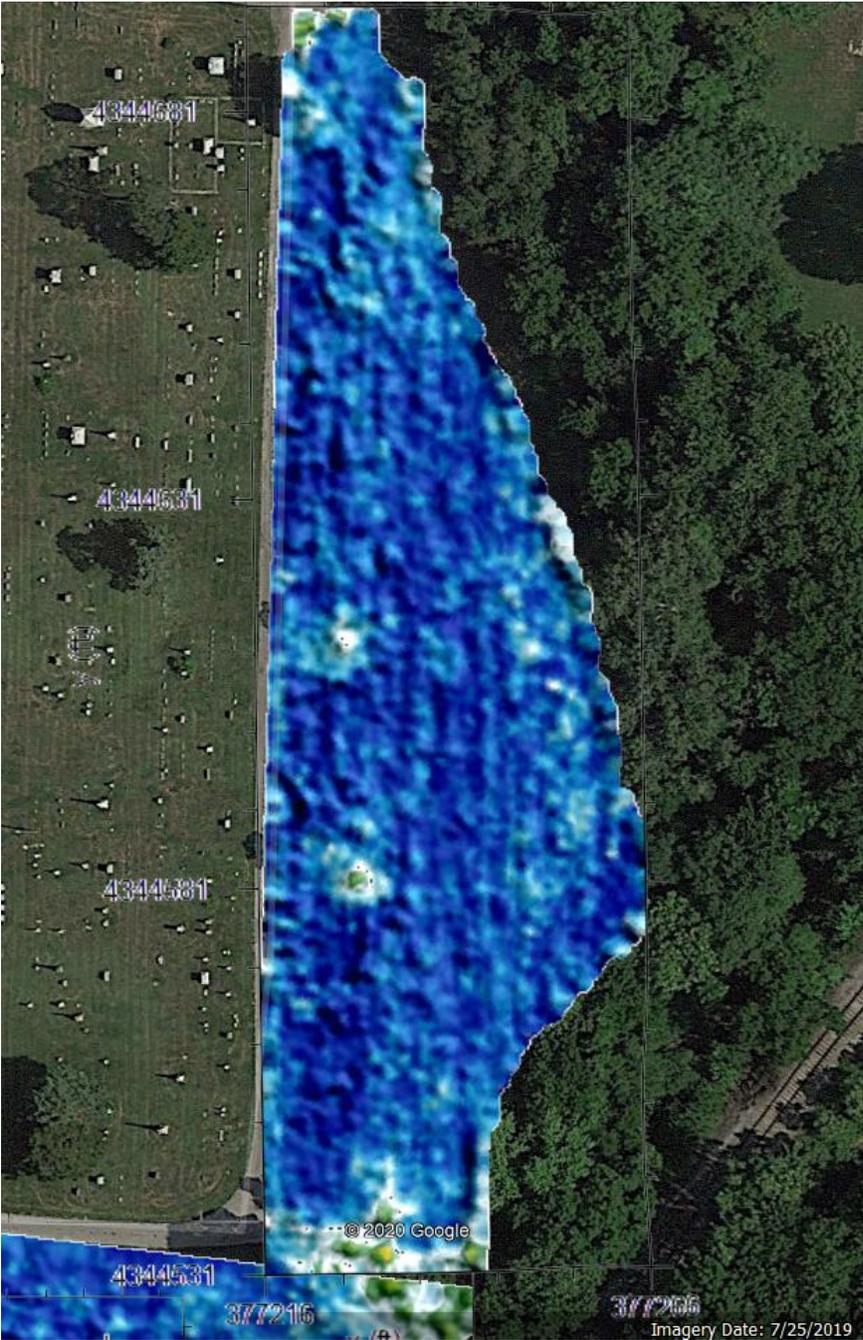
Figure 13

In Figure 13, which is the aggregate overlay of weakest reflections, some reflections on the east side of the section appear which indicates some backfill in this area. This may or may not be correlated to unmarked graves but does show disruption in this area not consistent with surrounding soils.
