RESOLUTION ADOPTING A NEW STORM WATER MASTER PLAN AND ASSOCIATED CAPITAL IMPROVEMENT PLAN FOR THE CITY OF LIBERTY AS DEVELOPED BY HDR ENGINEERING INC.

City of Liberty - Stormwater Master Plan
Technical Memorandum

City of Liberty, Missouri – Stormwater Master Plan Condition Assessment Summary Report

Stream Assessment Findings Summary

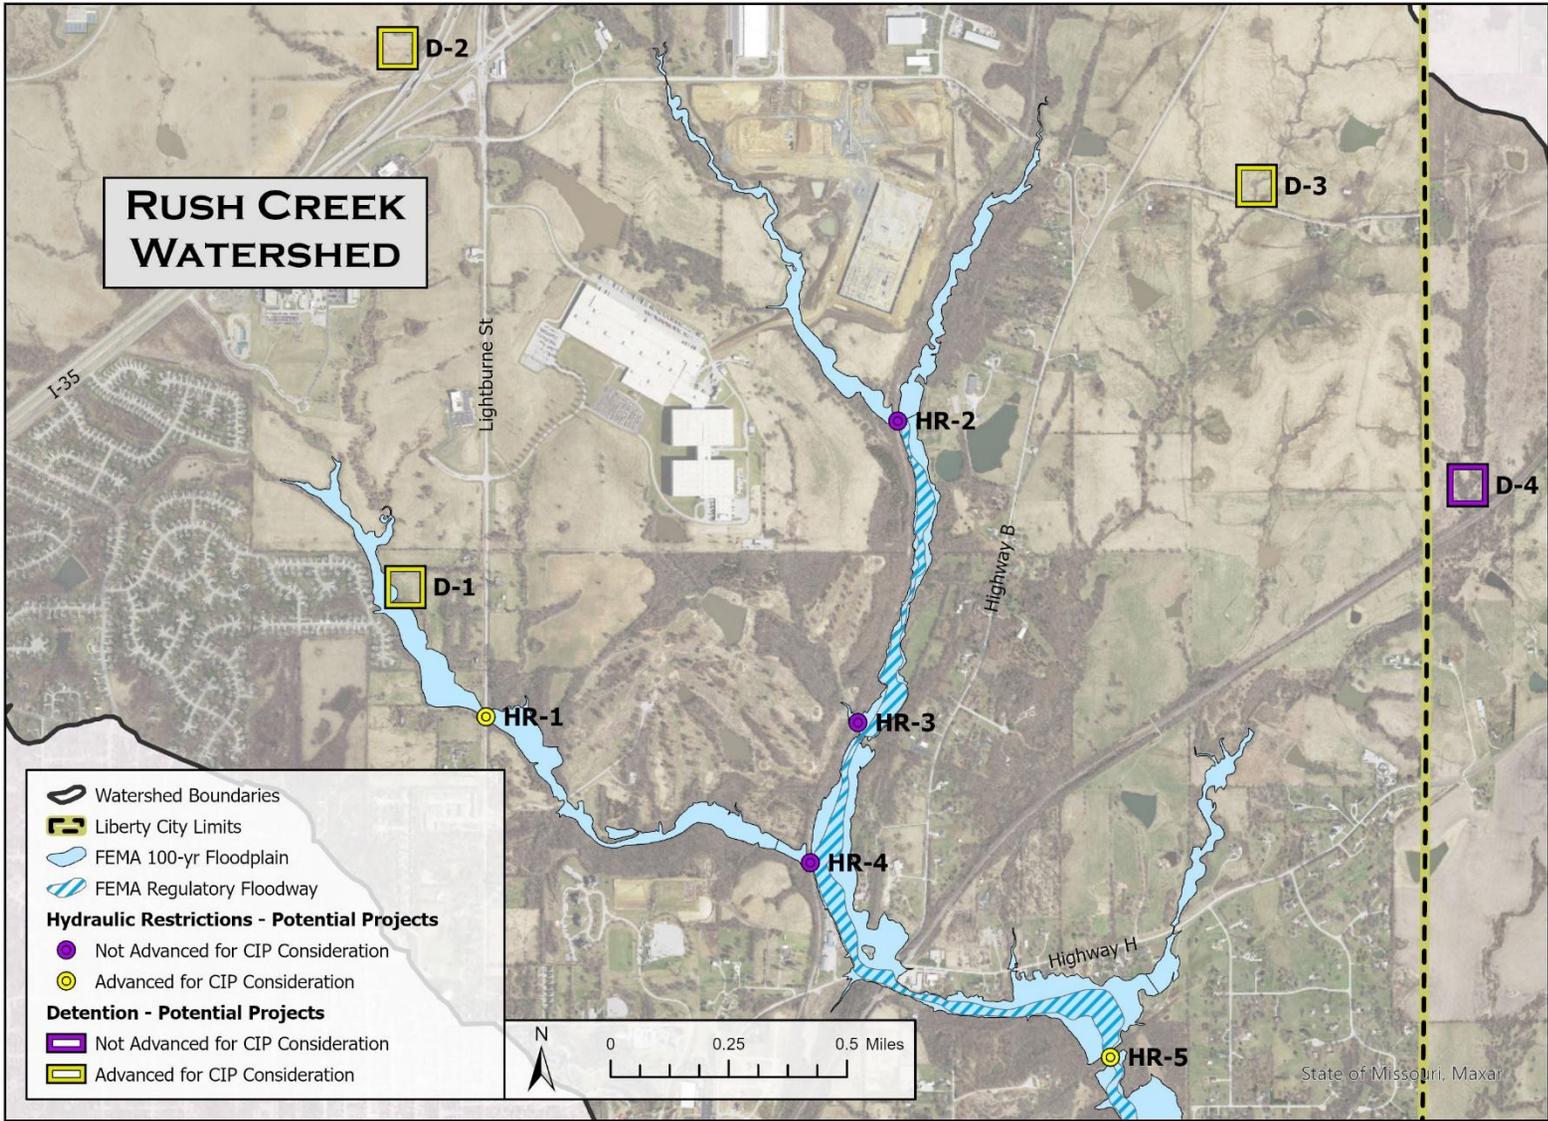
Figure 2: Potential Flood Risk Reduction Projects Identified within Rush Creek

Hydraulic restrictions identified from the various data sources are summarized in Figures 2 and 3. The locations are designated with a project identifier starting with the prefix 'HR-'. The potential sites were evaluated and further vetted to identify areas where a hydraulic improvement would offer maximum benefit to surrounding public and private properties and increase roadway level service, which would improve public safety and reduce flooding. Considerations for right-of-way and required acquisitions were also noted as the projects were being evaluated. Project improvements that extend beyond City right-of-way can face additional challenges, including increased coordination and higher cost if additional right-of-way or easements are needed. Through this process, the overall benefit of the potential improvement was compared and only the projects with the greatest potential benefit advanced for CIP consideration. All locations are included in the Liberty Stormwater Master Plan hub site; however, for purposes of this Flood Risk Assessment, the projects were classified as those that were or were not advanced for CIP consideration. Additional details are provided in Table 1 for each potential project location.

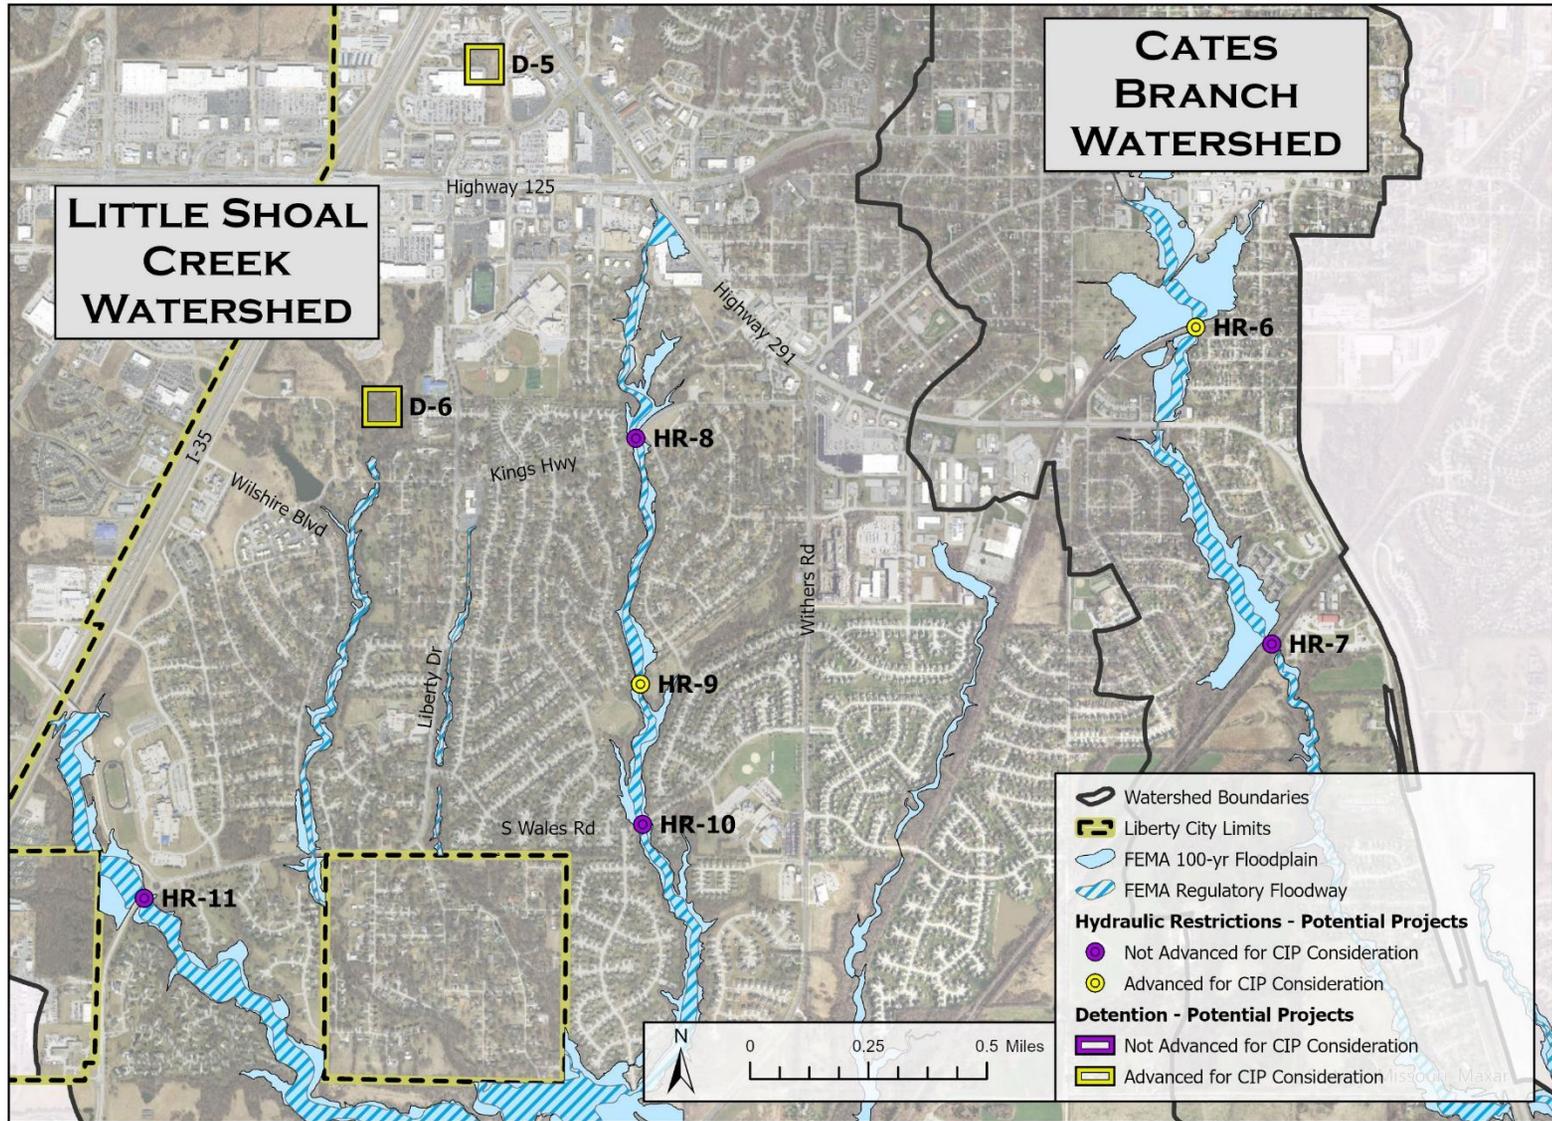
Figure 3: Potential Flood Risk Reduction Projects Identified within Cates Branch and Little Shoal Creek

Project ID	Watershed	Stormwater Challenge / Benefit	Advanced for CIP Consideration
HR-9	Little Shoal Creek	Existing 2 - 14' W x 10' H RCB. Substantial hydraulic restriction along Little Shoal Creek Tributary 5 and a side road located between Liberty Drive and South Wales Road within the Westboro-Canterbury Greenway. Located in FEMA floodplain and regulatory floodway. FEMA flood profile indicates ~ 7 ft of headwater at structure. Two homes within 100-year floodplain. Work within floodway would require no-rise certification. Increasing structure capacity could reduce headwater, reducing flood elevations at residential properties.	Yes
HR-10	Little Shoal Creek	Existing 2 - 15' W x 10' H RCB. Hydraulic restriction along Little Shoal Creek Tributary 5 and S. Wales Road. Located in FEMA floodplain and regulatory floodway. Restriction does not appear to negatively impact public or private infrastructure for the 100-year base flood. ICM modeling results indicate street flooding; however, appears to be from local stormwater system flooding and not the roadway crossing.	No

HR-11	Little Shoal Creek	Existing 2 - 14' W x 12' H RCB. Substantial hydraulic restriction along Little Shoal Creek at Liberty Drive crossing. Located in FEMA floodplain and regulatory floodway. Minor street flooding within 100-year floodplain, no other visible impacts to public or private infrastructure.	No

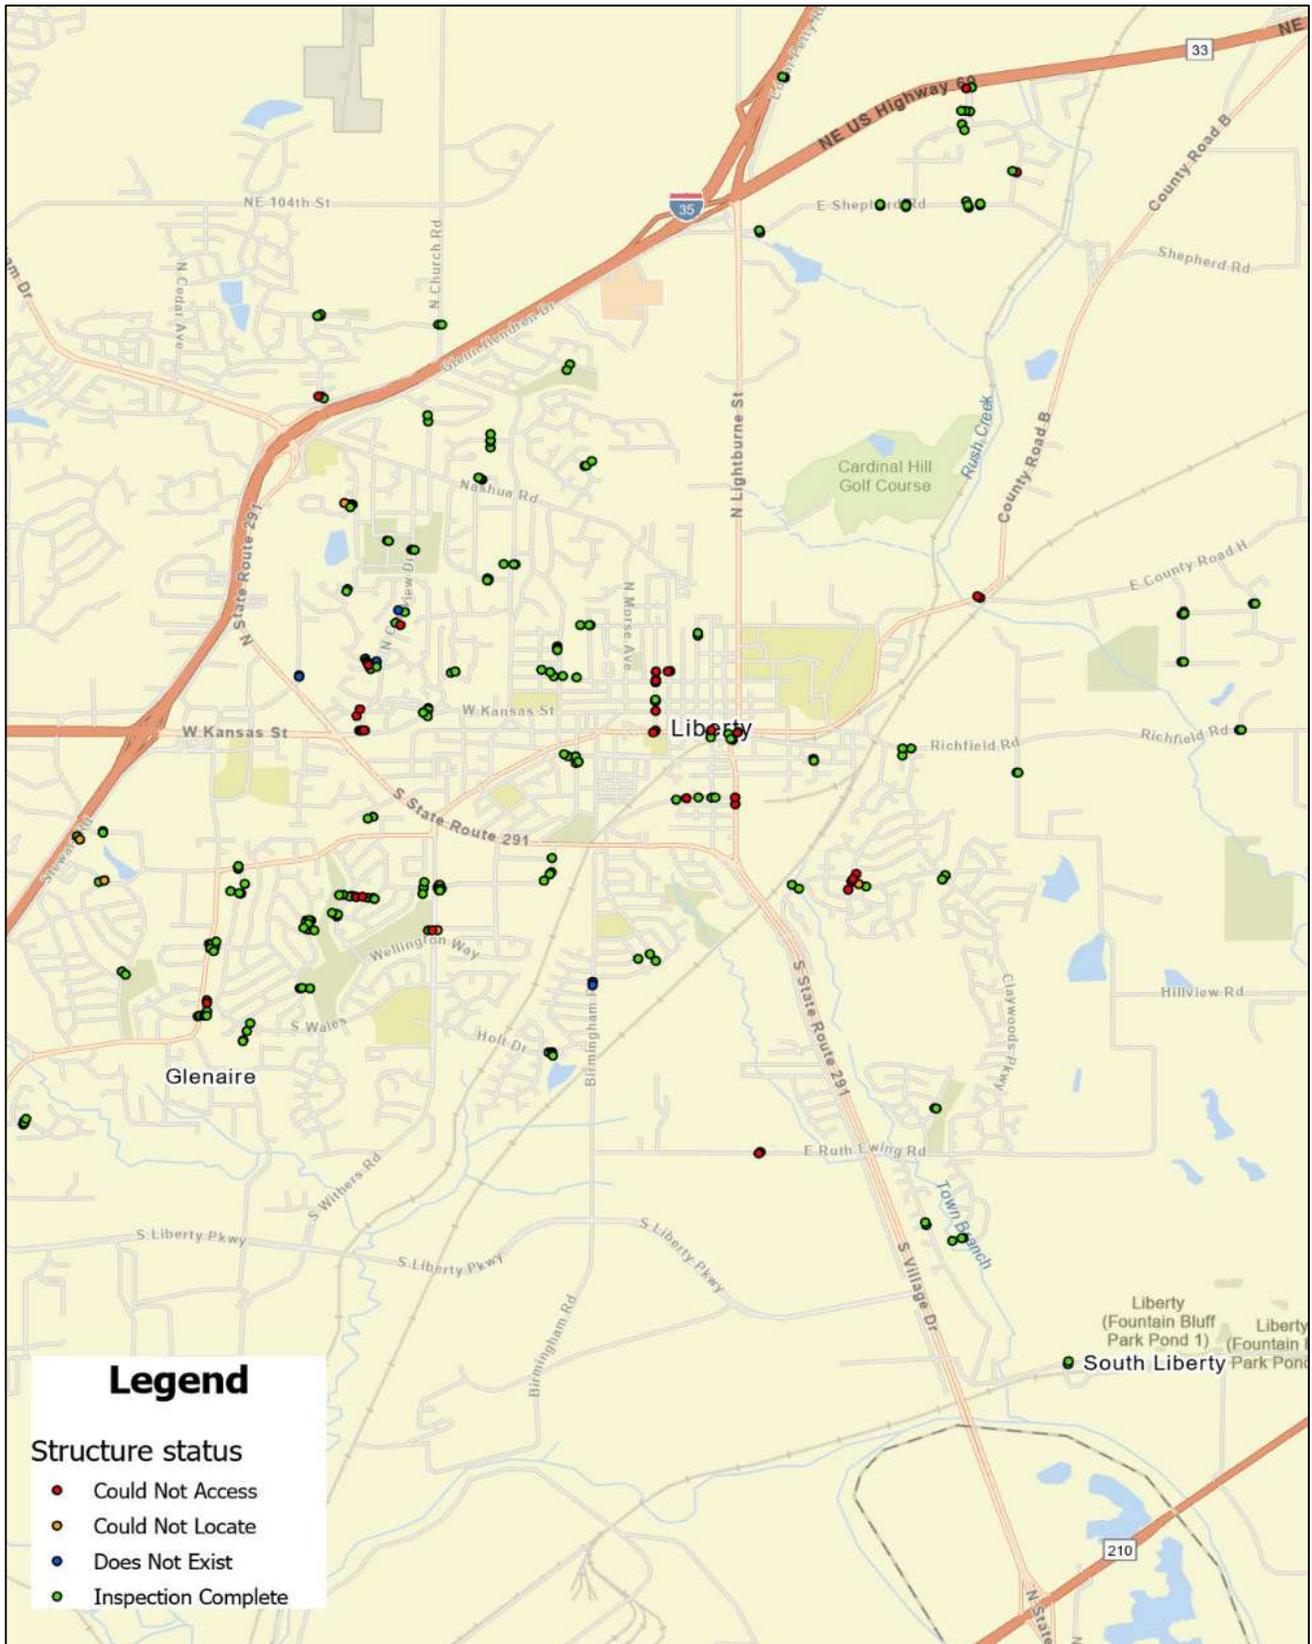
Figure 2-1 Structure Inspection Status

A total of 281 stormwater structures were attempted to be inspected. However, it was found through the field inspections that there were portions of the GIS were not accurate. Some of the structures in the GIS did not exist in the field and were noted. Of the total 281 storm sewer structures 223 were inspected. Table 2-1 summarizes the total structures inspected and the number of structures that could not or were not inspected. Structures that could not be accessed may be buried or are in an area where they could not be reached to complete an inspection. The inspection status of each structure is represented visually in Figure 2-2.

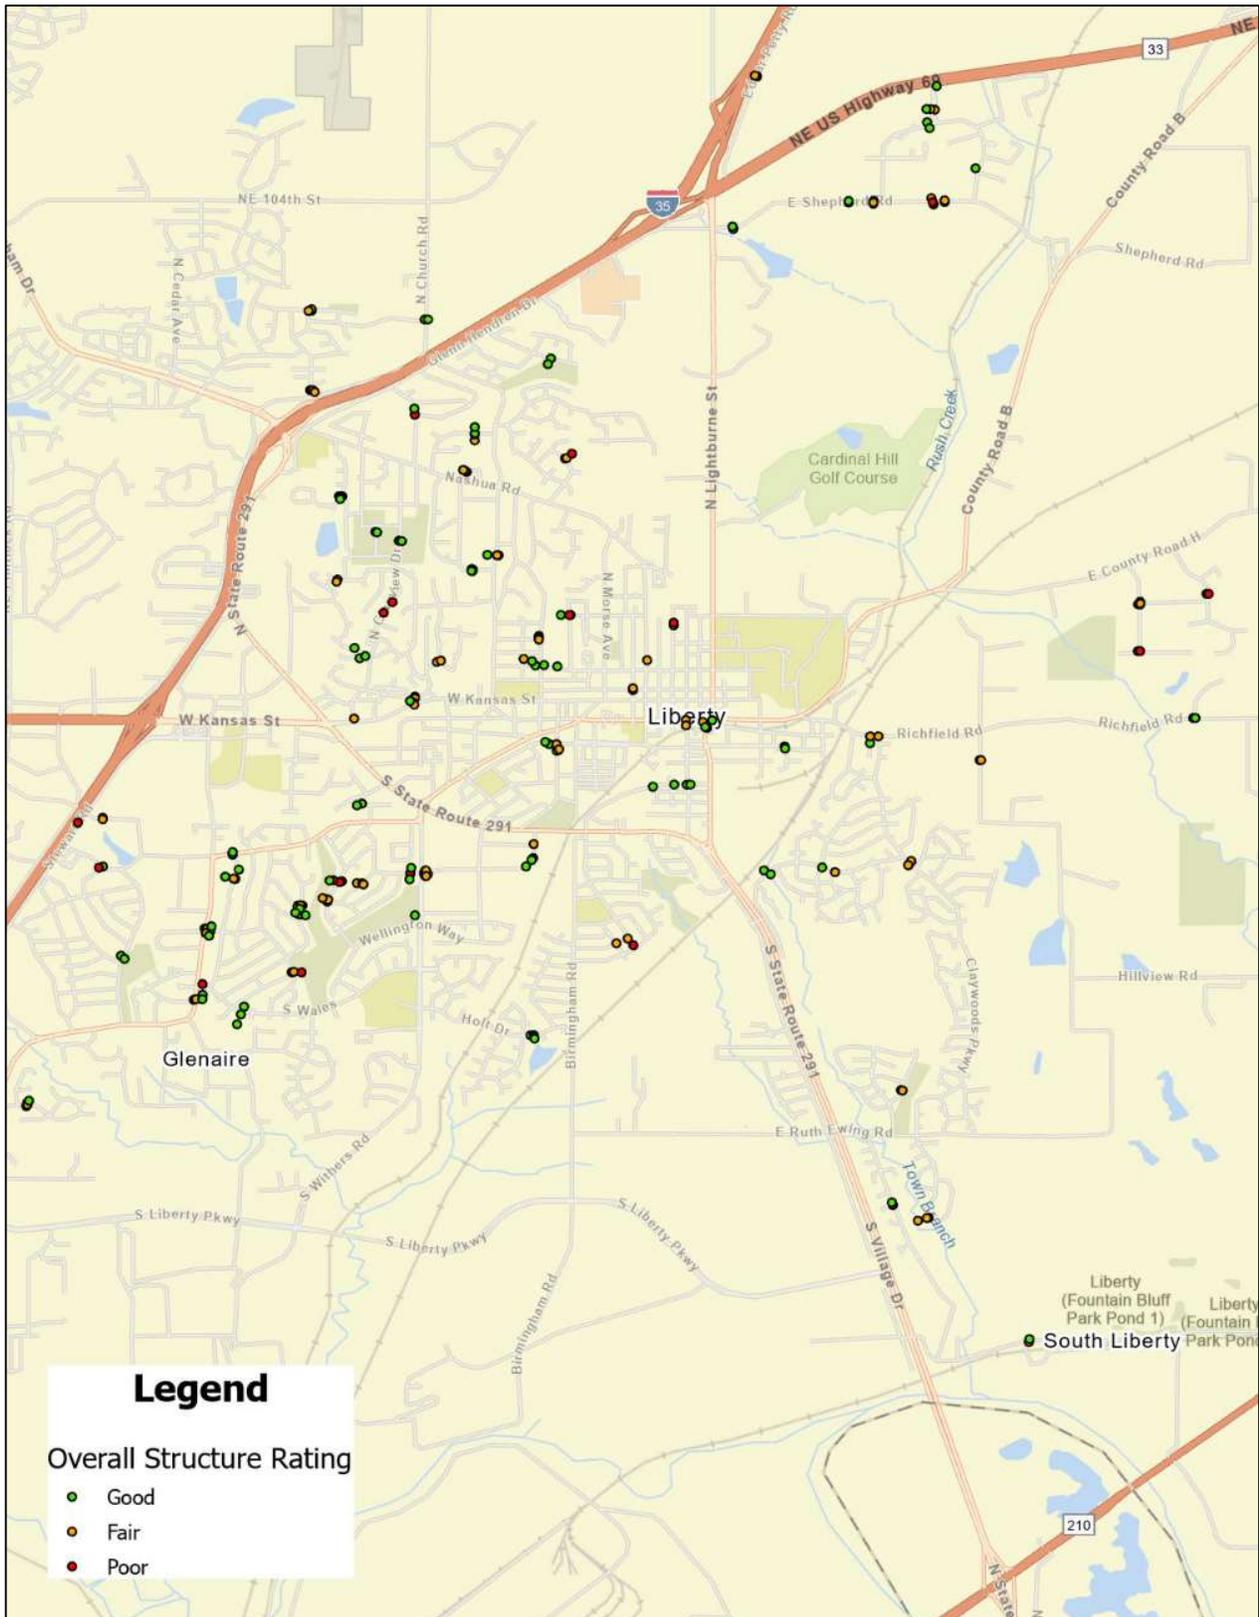
Figure 2-2 Structure Overall Condition Rating

Each structural component was assigned a score as described above. The majority of the stormwater structures are in good condition. The slab, throat, and walls of the structures have the largest fair and poor condition ratings. Table 2-2 summarizes the condition ratings for each structure inspected.

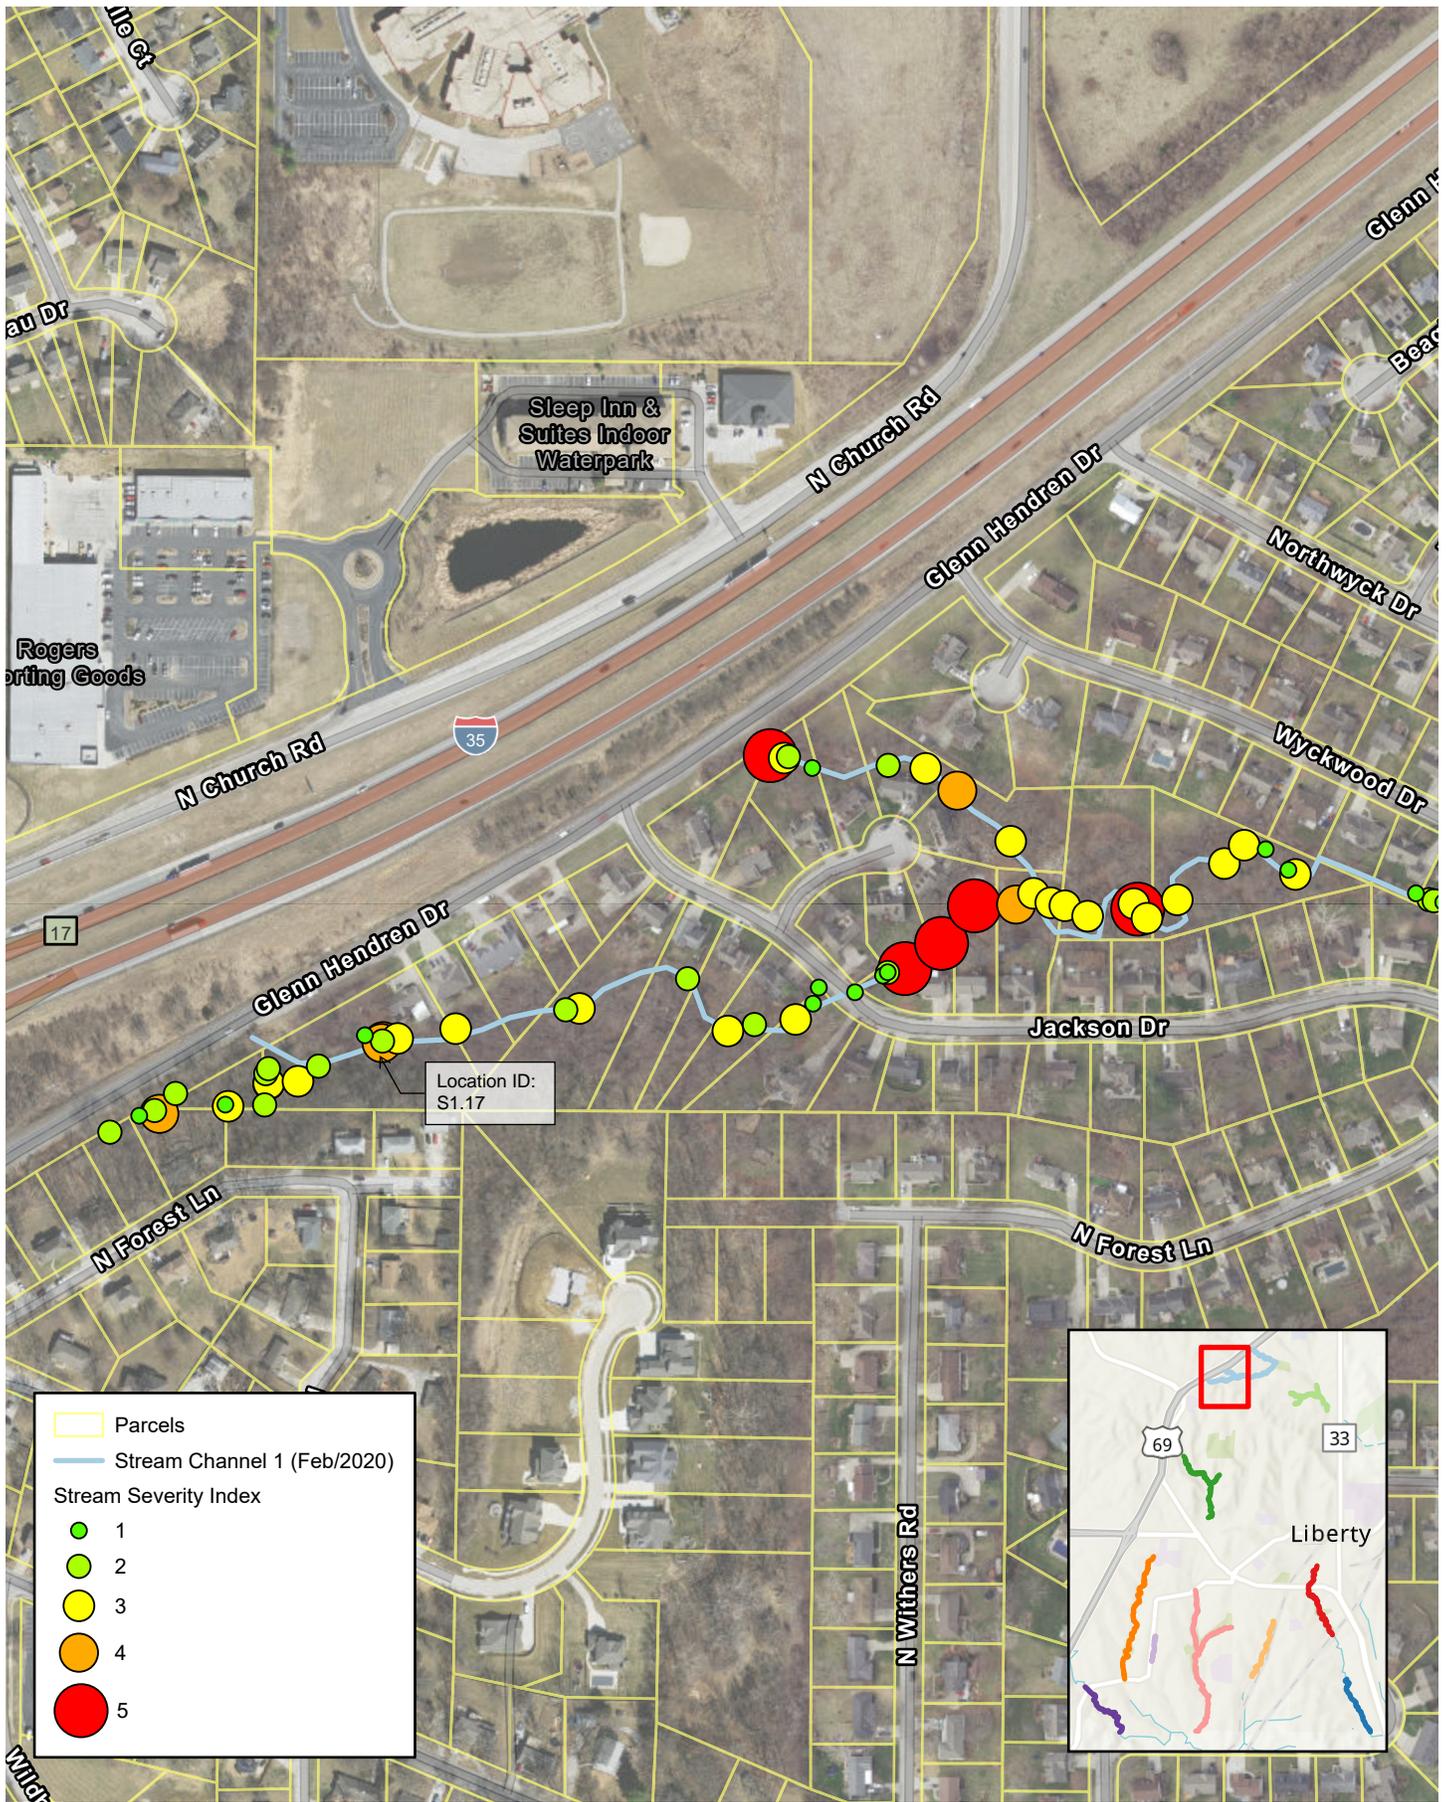
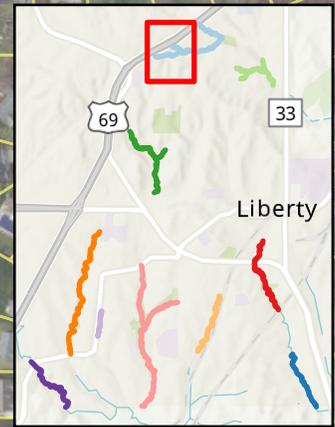
Figure 1-1

Figure 2-2 illustrates the bank erosion posing a threat to nearby residences and exposing a manhole. Multiple instances of infrastructure risk were identified during investigations of Stream 1. Table 2-3 displays the inventory of instability concerns identified with severity rating of 3 or higher along Stream 1.

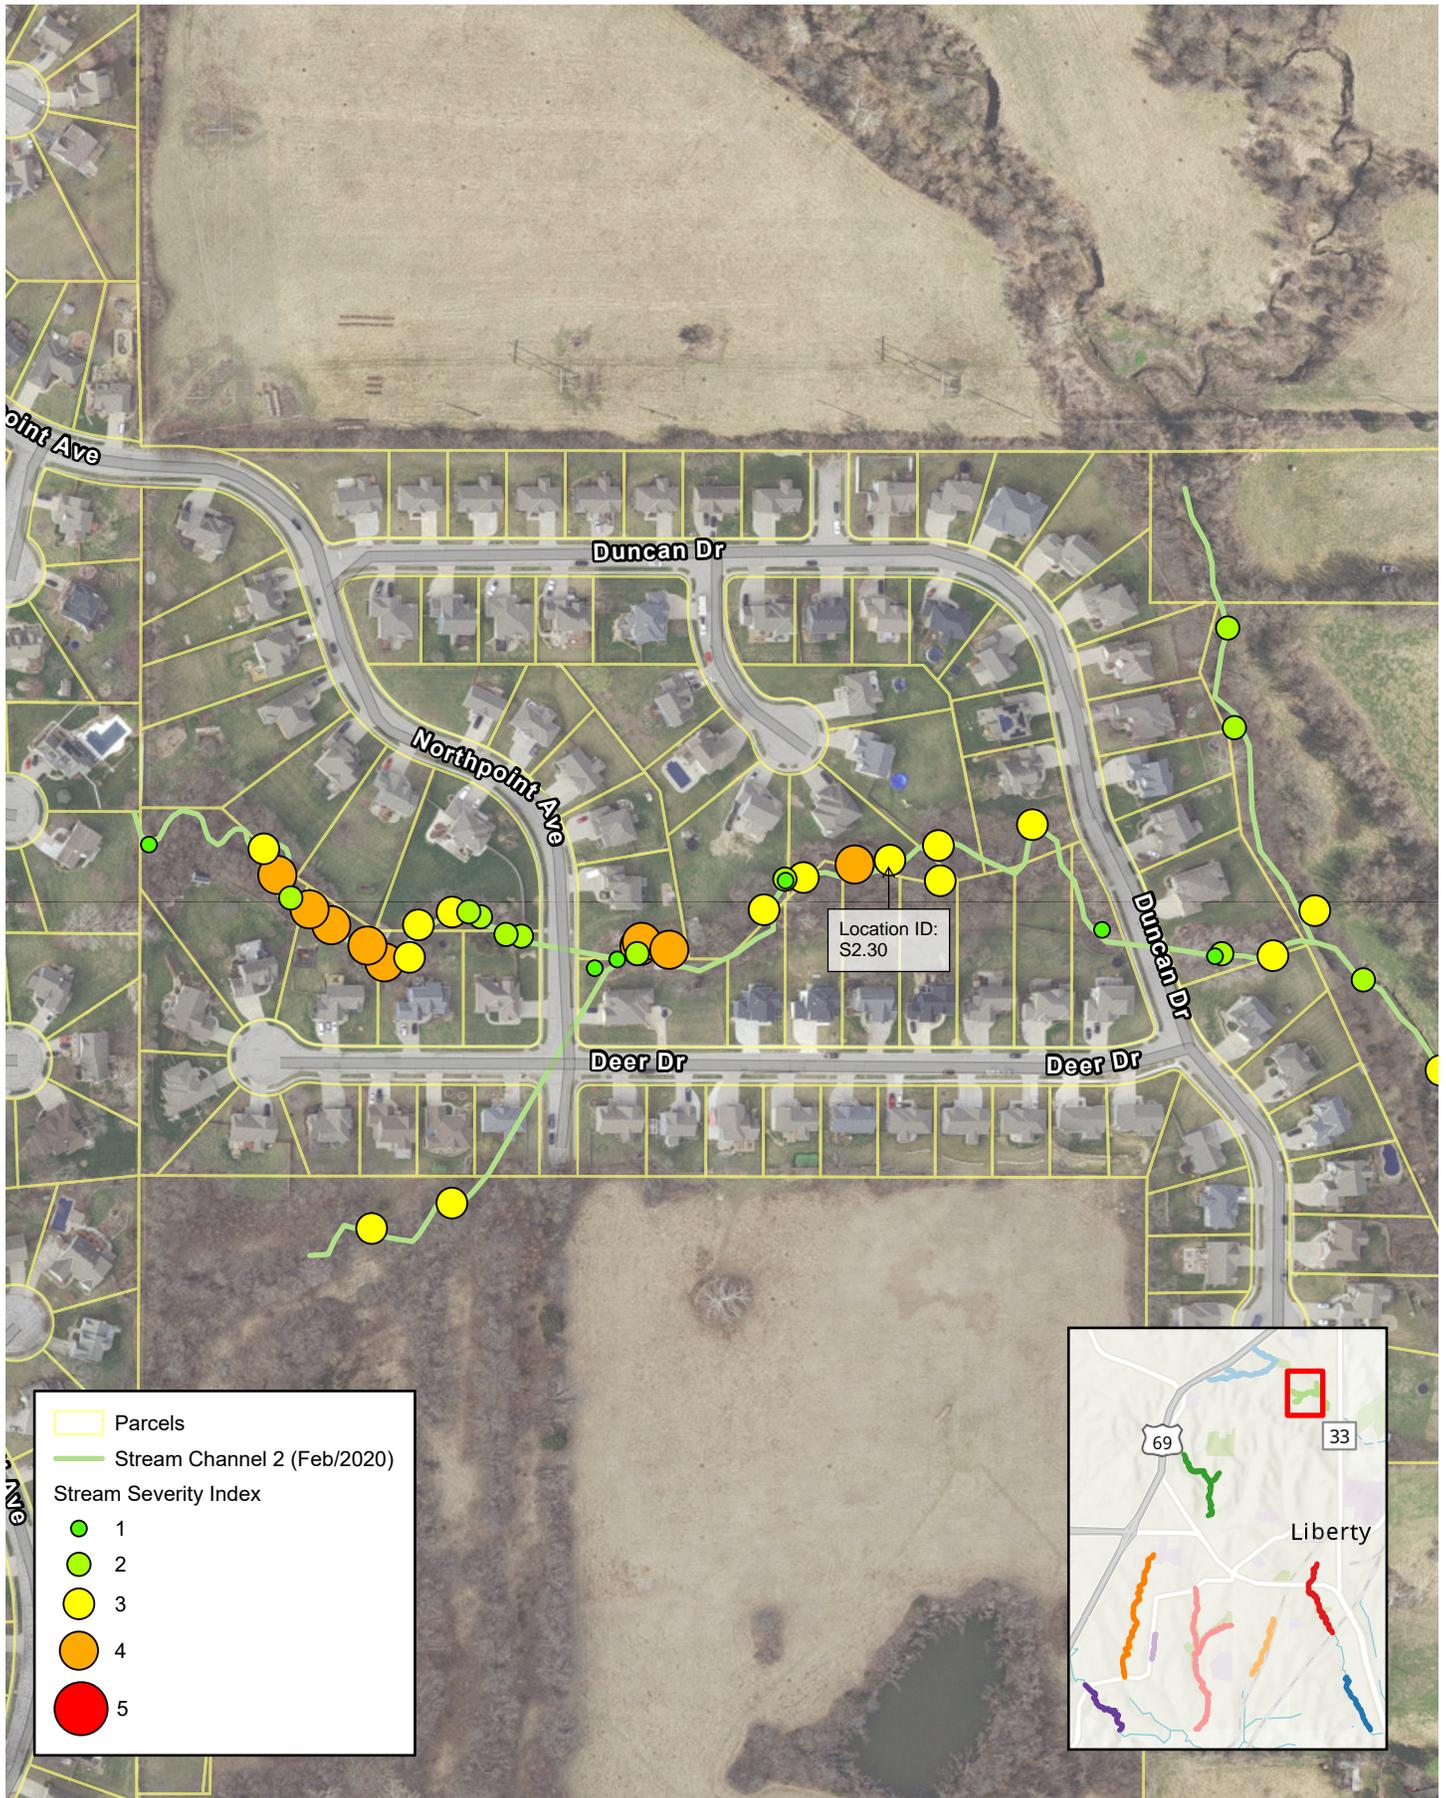
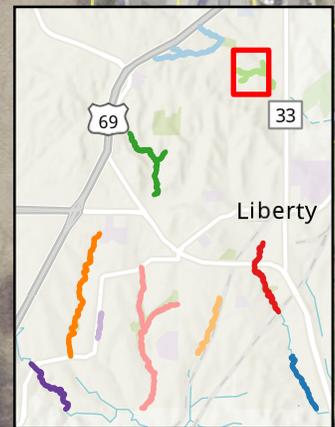
Figure 1-3

The erosion of the stream banks poses risks to nearby residential buildings and public infrastructure, as evidenced in the Figure 2-3, which depicts the presence of slump-off slope without vegetation and meander downcutting along the bank.

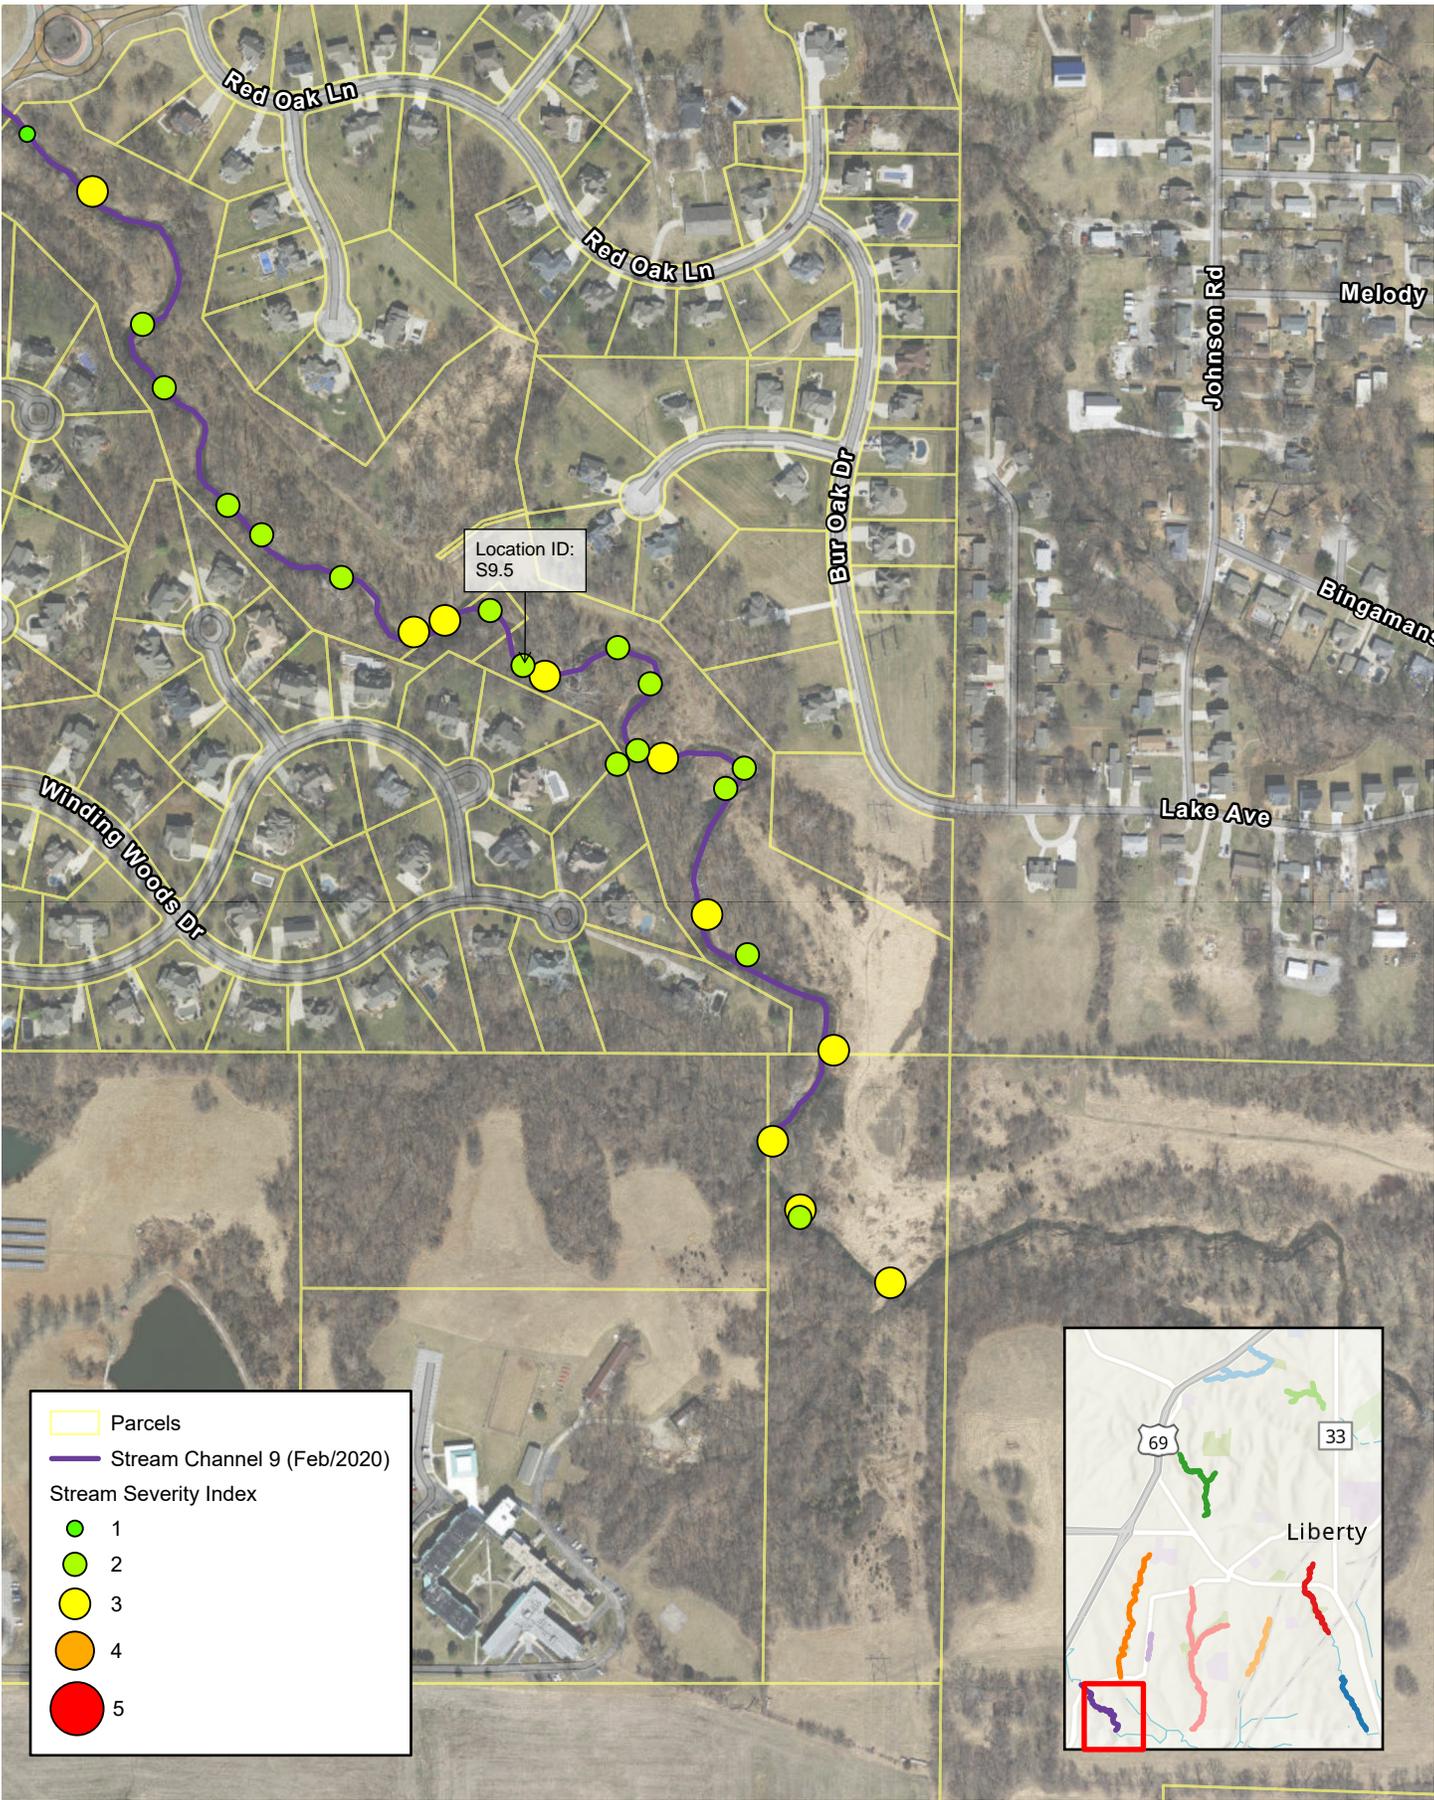
STREAM BANK ASSESSMENT
Figure 1-24

Investigation of Stream 9 began near the Southwest of Oak Crest Dr. on Little Shoal Creek and concluded near a roundabout located between Liberty Dr. and Flintlock Rd. Stream 9 detailed map is available within Appendix A, Figures 1-24 and 1-25.

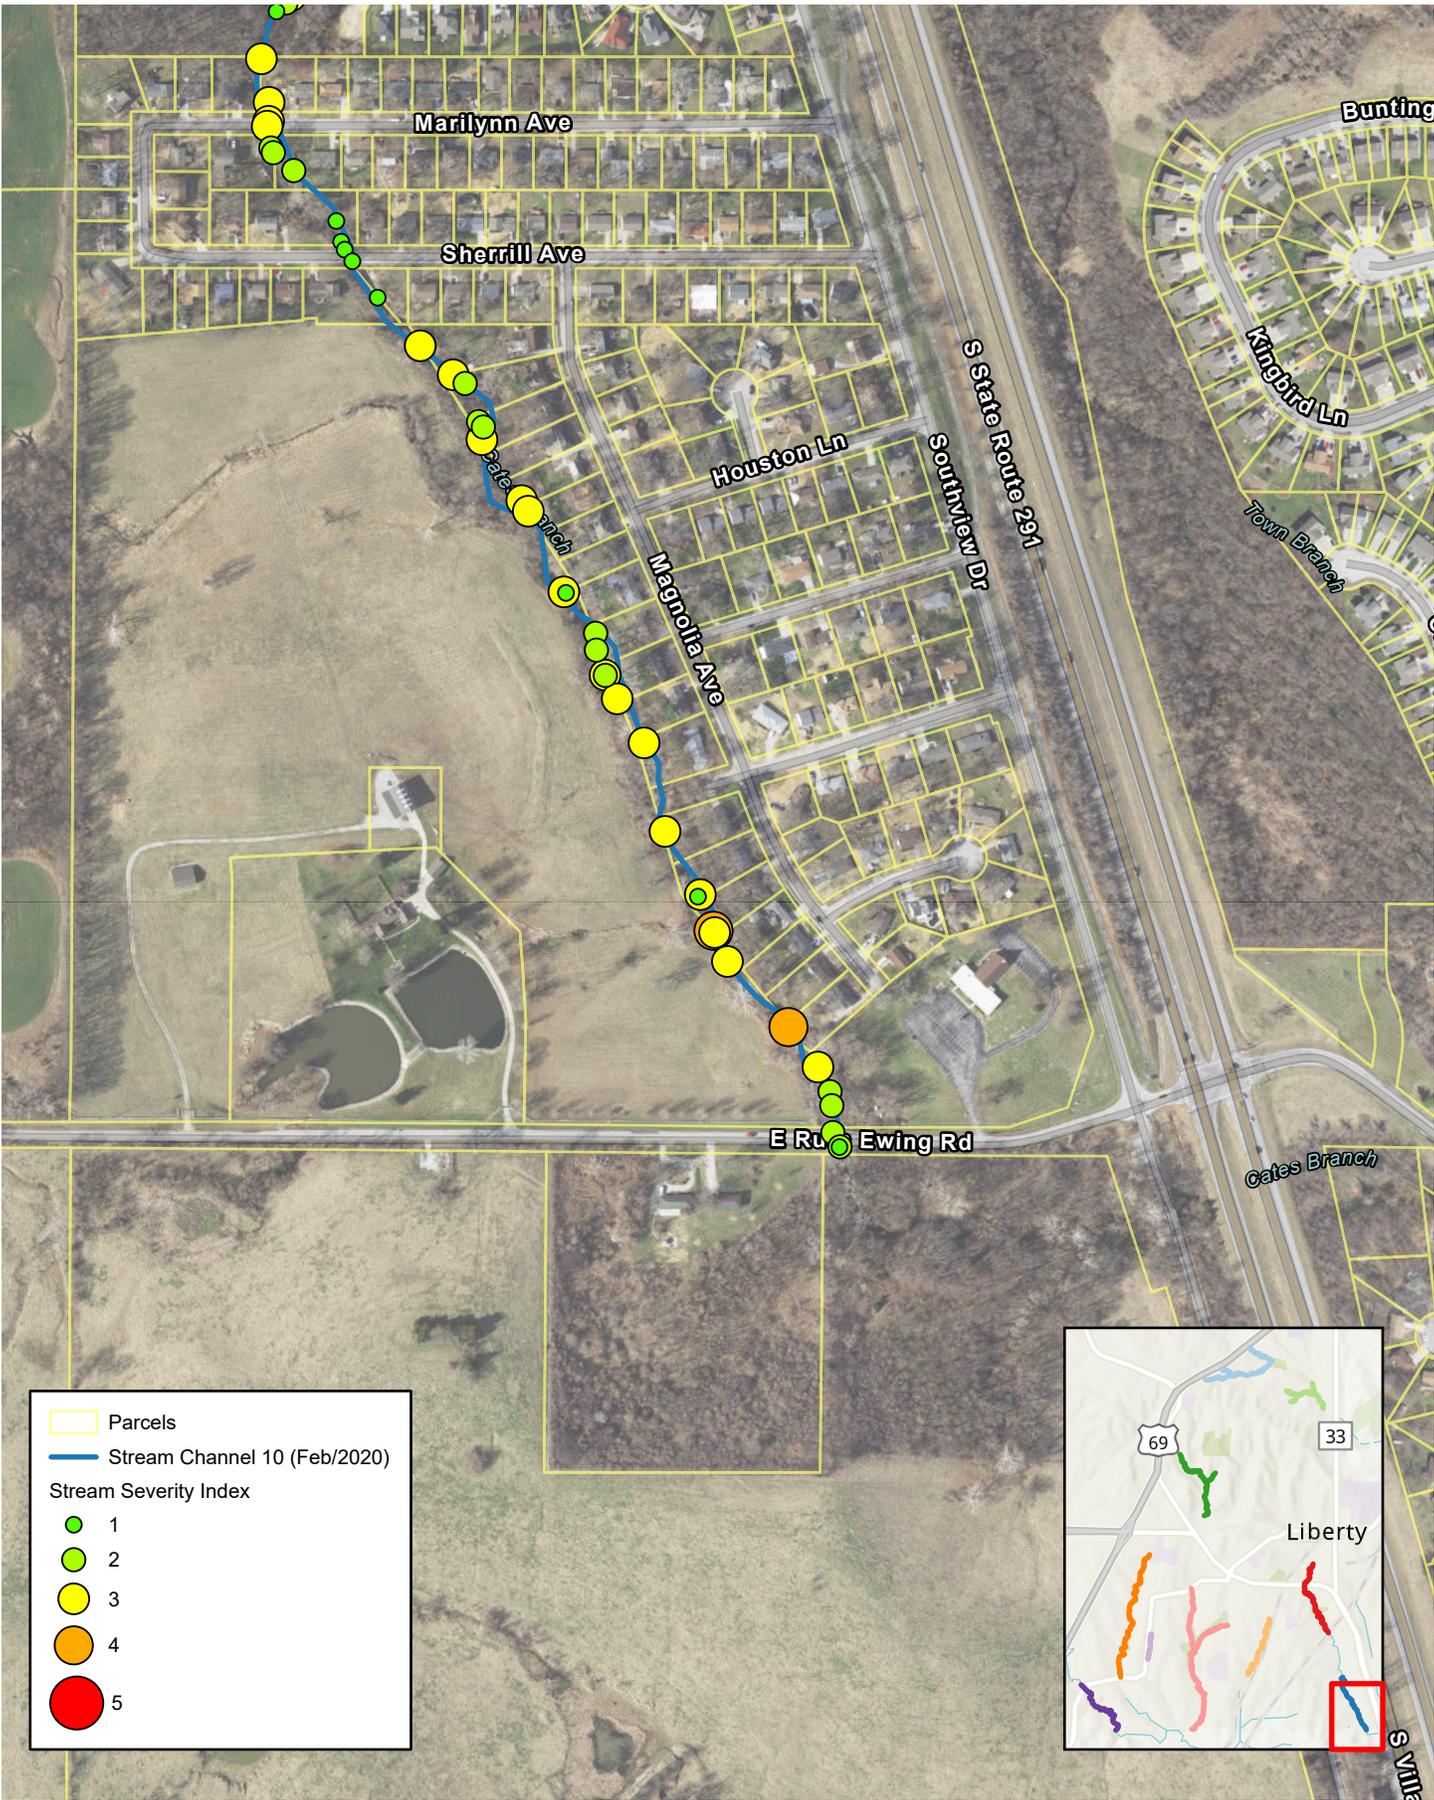
Figure 1-26

Investigation of Stream 10 began near Fawn Ln and concluded near the intersection of E Ruth Ewing Rd. and Southview Dr. Stream 10 detailed map is available within Appendix A, Figures 1-26 and 1-27.
